Building Inspections

## **INSPECTION REPORT**

1439 Tunnel Road  
Santa Barbara, CA

October 31, 2017

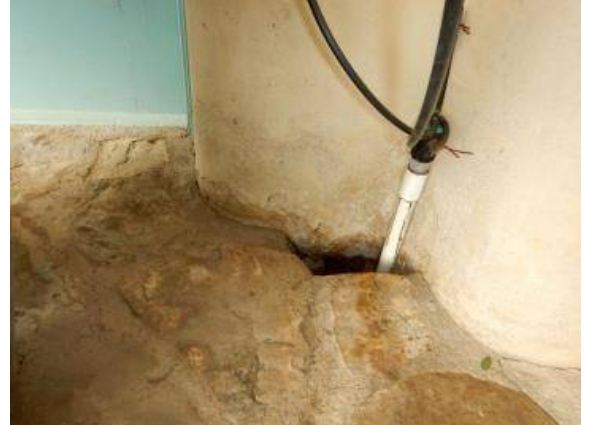
Open cracks were noted in various places at the exterior walls. Recommend sealing open cracks to help prevent water intrusion.

Damaged stucco was noted adjacent to the patio between the entry and living room.

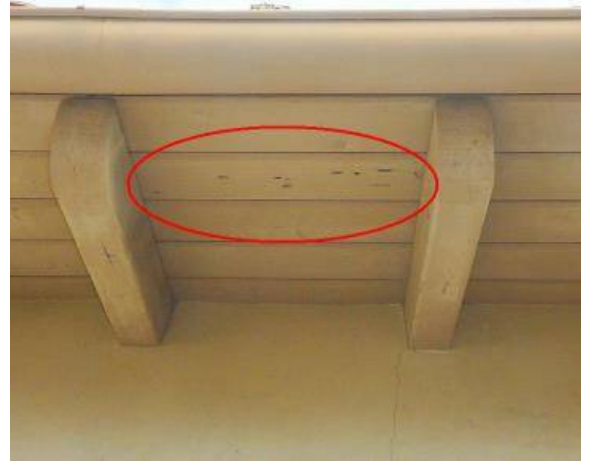
Apparent insect damage was noted in various places at the eaves and master bedroom balcony. Recommend the entire property be inspected by a licensed structural pest control operator.

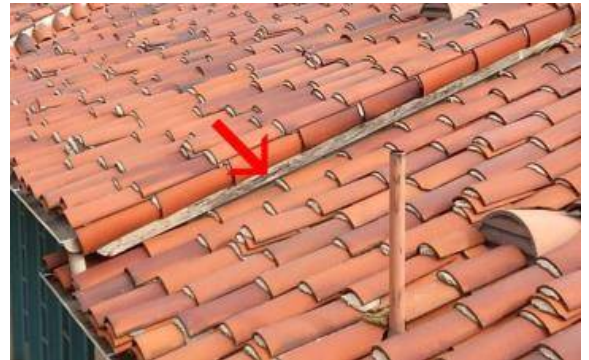
An excessively weathered fascia board was noted between the upper and lower roofs at the upper south portion of the house.

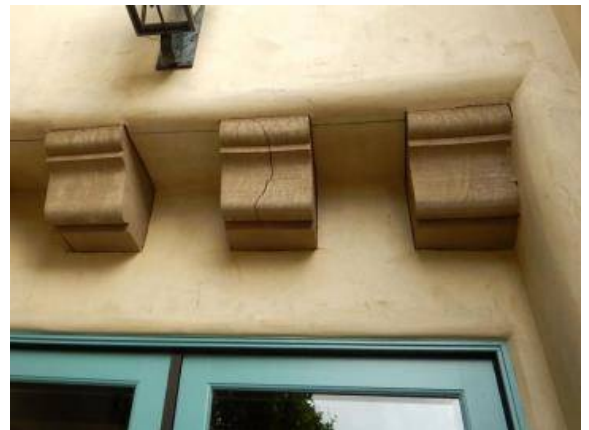
Weathered wood components were noted in various places at the exterior of the building.

Recommend all exterior wood components be painted or sealed as needed by a licensed painting contractor to help prevent moisture damage.

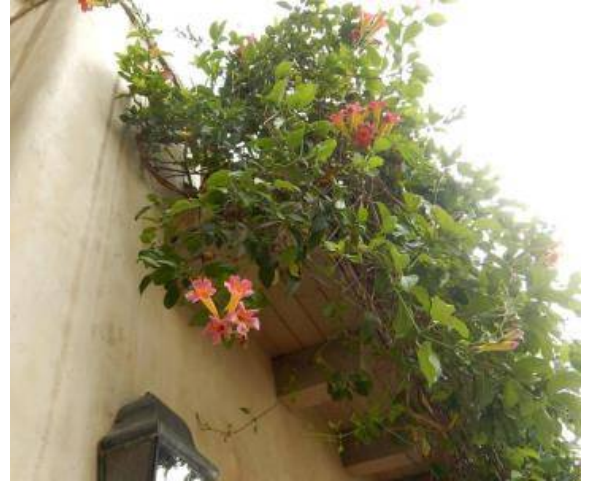
The balconies and related components were not fully visible due to foliage.

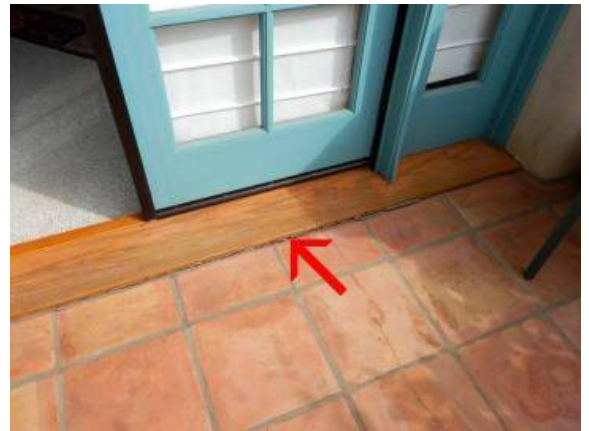
Gaps were noted between the threshold and tile at the master bedroom balcony.

Recommend all of the balconies and related components be inspected and improved or replaced as needed by a qualified licensed contractor.

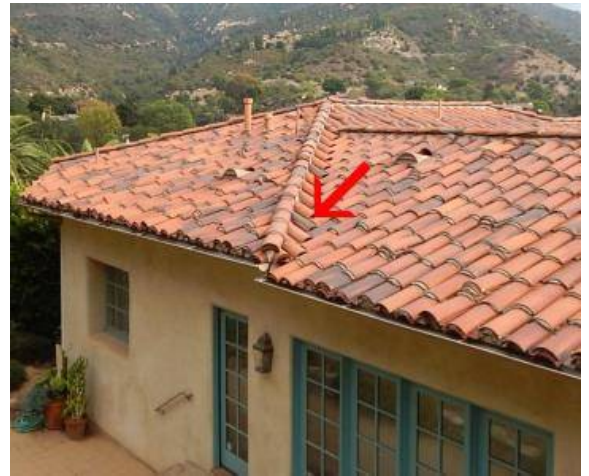
Moisture stains and damage were noted at the upper hallway ceiling and wall toward the rear of the building.

Leakage may have occurred from a valley above the upper hallway toward the rear of the building.

Recommend the roofs and related components be inspected and improved as needed by a licensed roofing contractor.

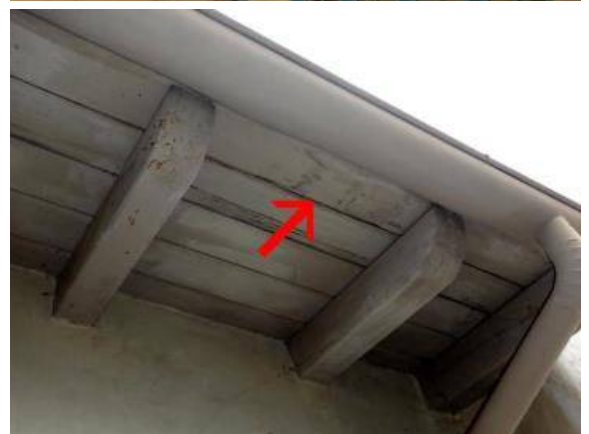
Moisture stains were noted at the eaves above the master bedroom balcony.

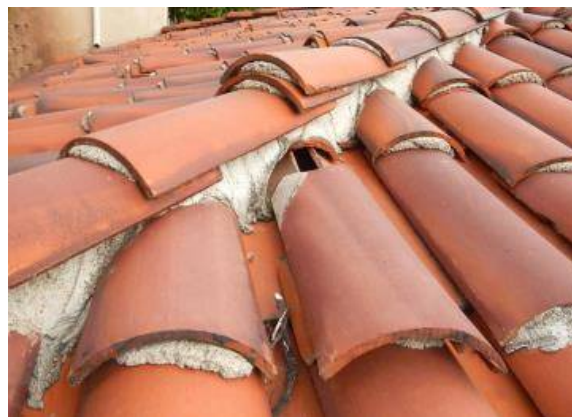
A broken roof tile was noted at the south side of the garage.

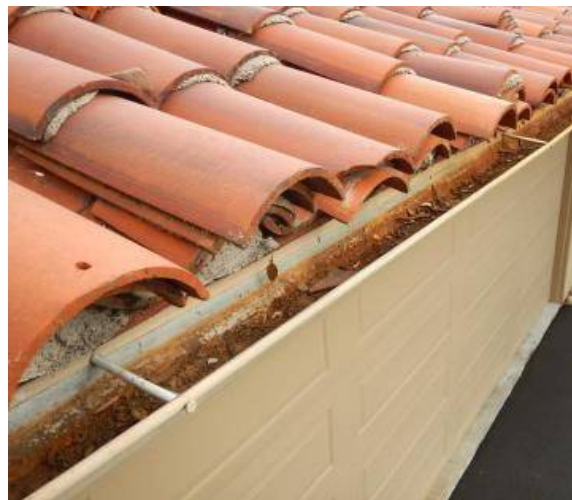
Corrosion was noted in various places at the gutters.

Recommend the gutters be cleaned, inspected, and improved as needed by a qualified licensed contractor.

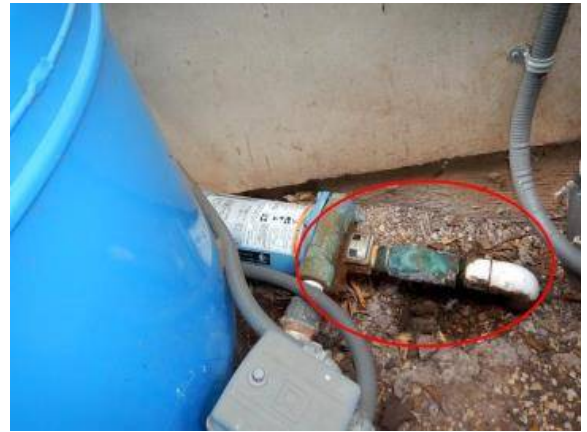
Leaking fittings were noted adjacent to a water pump at the north exterior.

Recommend the water pump, pressure tank, and related components at the north exterior be inspected and improved as needed by a licensed plumbing contractor.

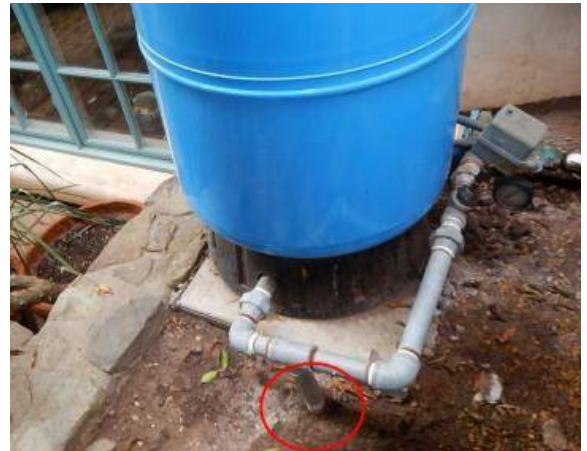
Corrosion was noted at a galvanized pipe adjacent to the pressure tank at the north exterior.

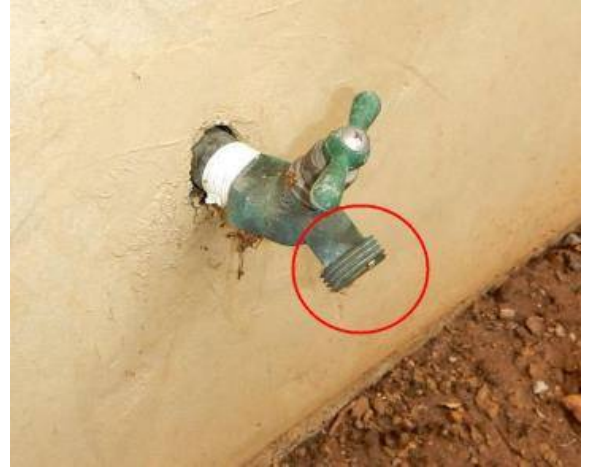
Lack of anti-siphon devices can allow water from the landscape to enter the potable water system, if hoses are left attached to faucets and the ends of the hoses are submerged.

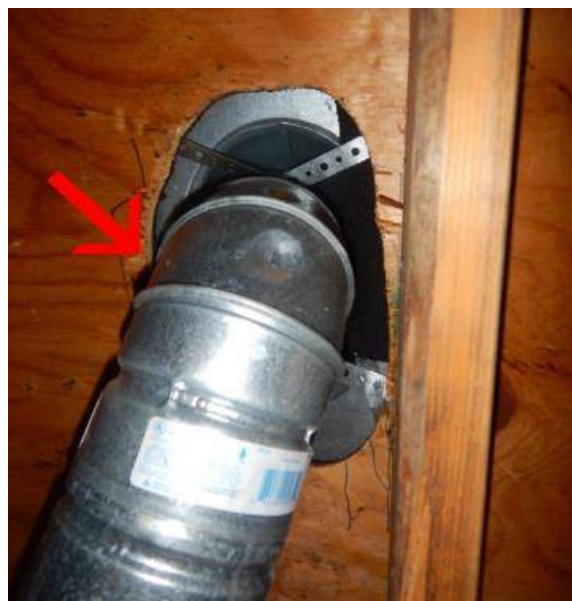
The furnace vent pipe is too close to wood at the roof sheathing in the attic. Recommend the wood be trimmed away 1" to provide adequate clearance.

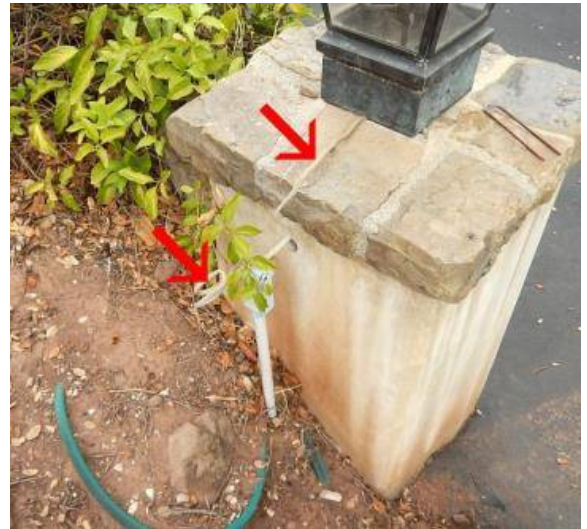
Temporary wiring was noted at a landscape light south of the garage. Landscape lighting and wiring is otherwise not within the scope of this inspection. Recommend further evaluation and improvements by a licensed electrician.

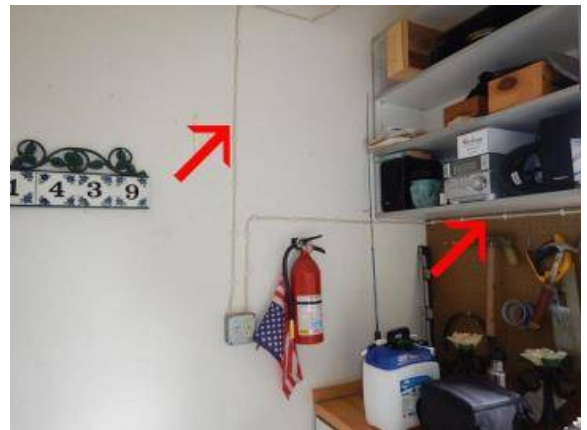
Temporary wiring was noted at various places in the garage. Recommend improvements be made by a licensed electrician.

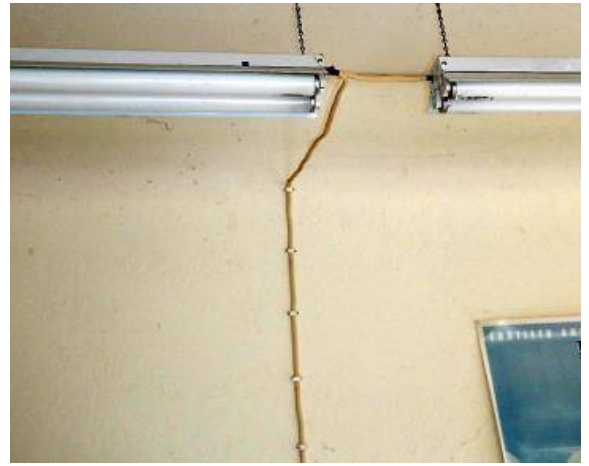
Temporary wiring was noted at various places in the garage.

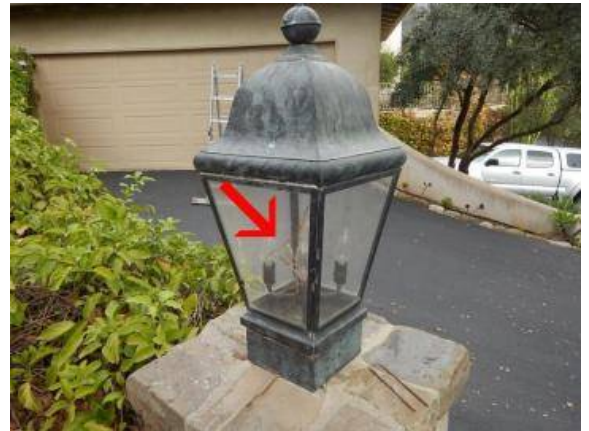
Ground Fault Circuit Interrupter (GFCI) protection is recommended at garage receptacles. The GFCI receptacle at the rear interior of the garage did not trip when tested. Recommend improvements be made by a licensed electrician. GFCI protection is recommended at all kitchen receptacles (the receptacles adjacent to the kitchen sink are GFCI protected). GFCI protection was not required at all kitchen receptacles at time of construction but is recommended. Broken glass was noted at a landscape light south of the garage.

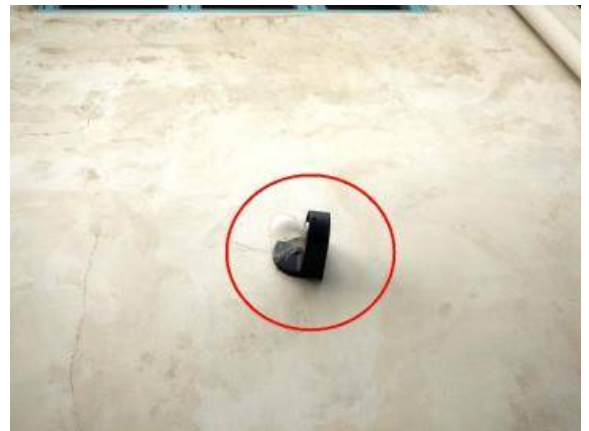
A displaced light fixture with a missing globe was noted at the north exterior.

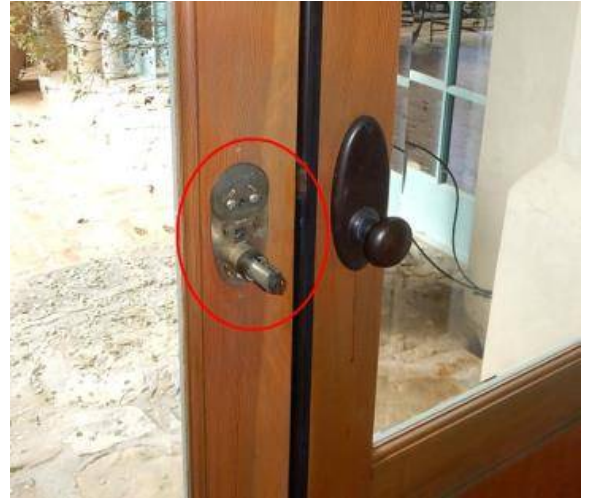
A missing plate and knob were noted at the entry doors.

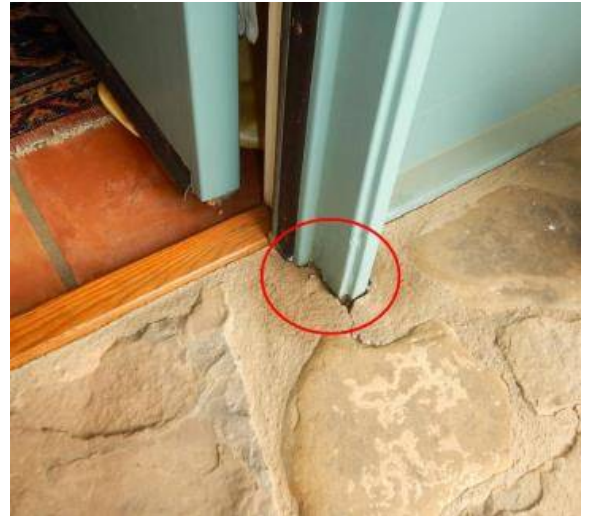
Some of the exterior door frames are embedded in paving. This can cause moisture damage. Recommend monitoring and improving as needed. Recommend keeping these areas well sealed to help prevent moisture damage.

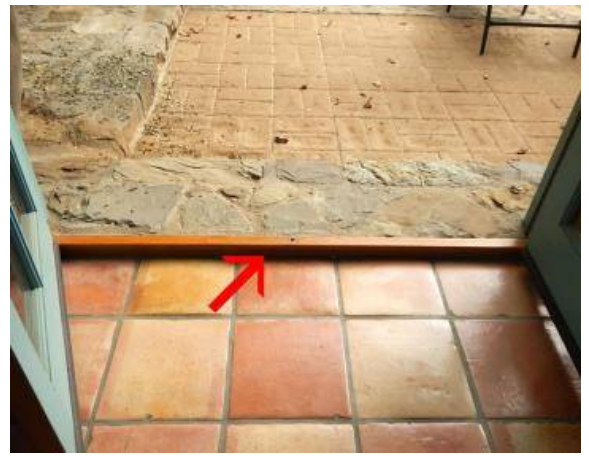
High thresholds were noted at the living room and family room. High thresholds can be trip hazards and are not to current standards.

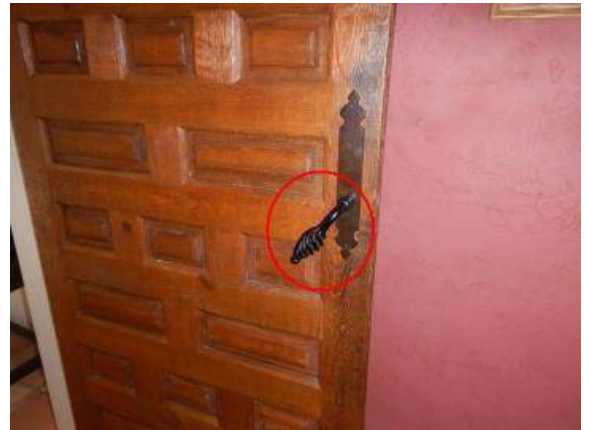
Weak springs were noted at the door hardware at the lower level bedroom. The door levers do not stay horizontal.

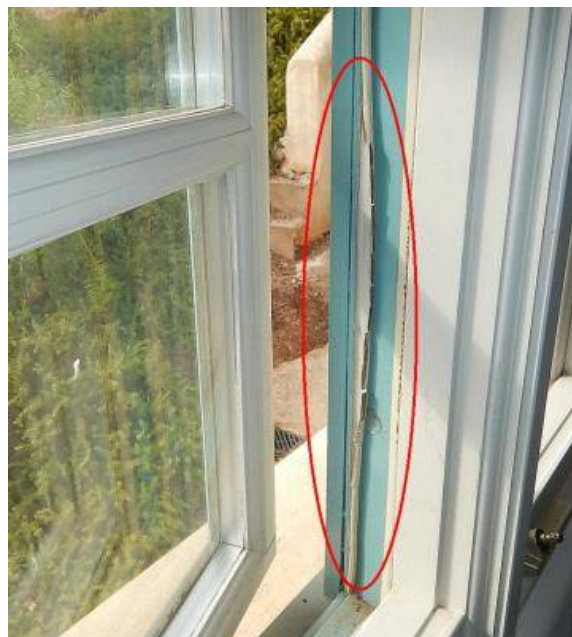
Damaged weatherstripping was noted in various places at the windows.

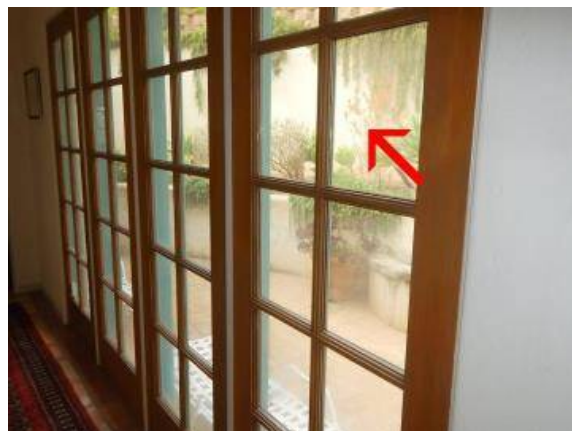
Fogging was noted between panes of glass at the upper hallway door and windows.

Additional failed dual pane windows and doors may be present, but not visible in all weather conditions or may be obscured by dirty glass. Recommend all of the windows and doors be cleaned to allow for further evaluation.

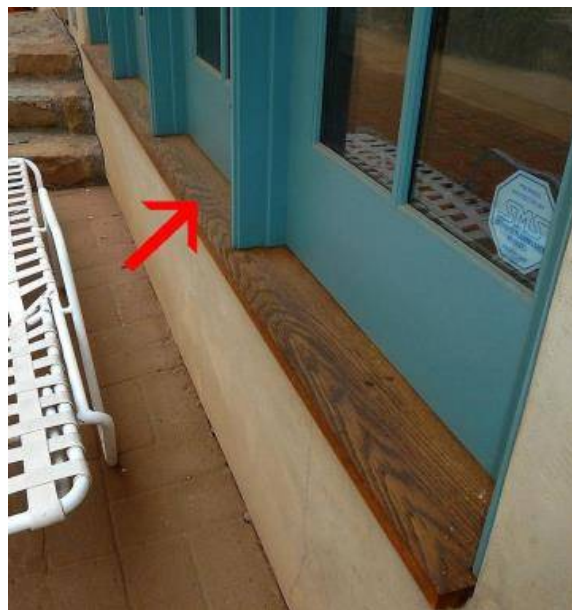
Weathered windowsills and thresholds were noted.

Recommend all of the windows, doors, and related components be inspected and improved or replaced as needed by a qualified licensed contractor.

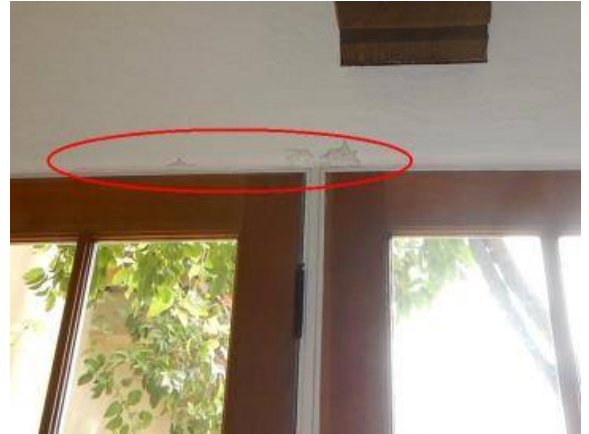
Moisture stains were noted at the wall above the living room exterior doors. Recommend further evaluation by a qualified licensed contractor.

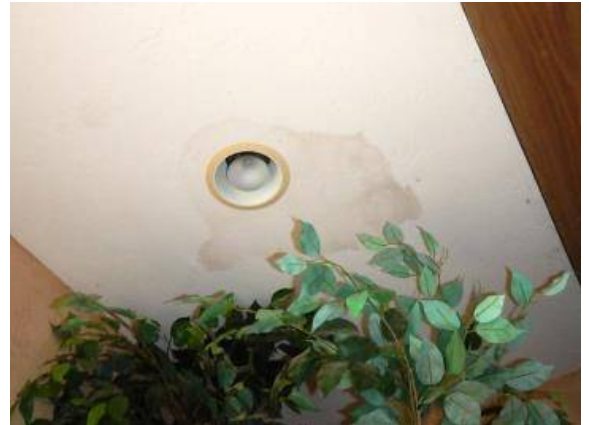
A moisture stain was noted at the family room ceiling below the balcony.

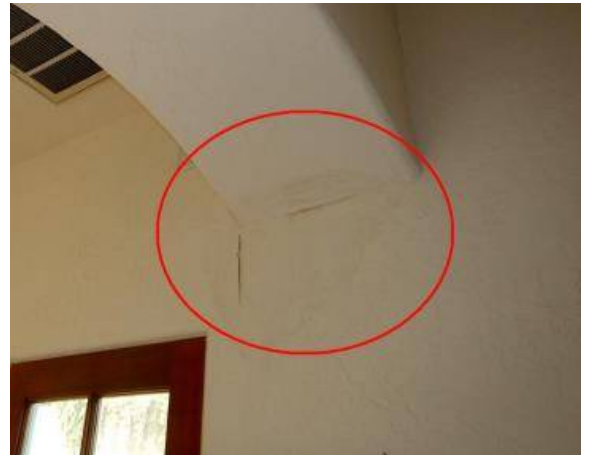
Moisture stains and damage were noted at the upper hallway ceiling and wall toward the rear of the building.

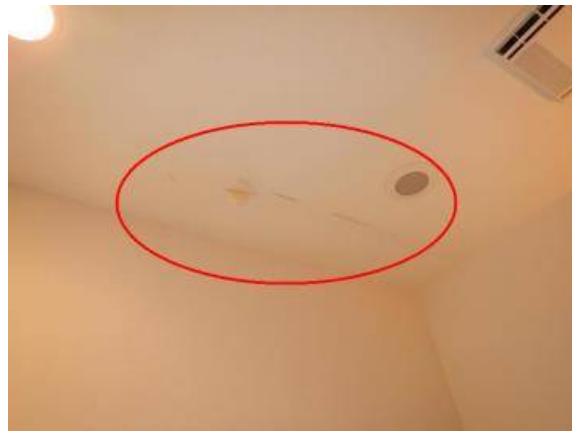
A moisture stain was noted at the dining room ceiling adjacent to the heating and cooling register. Recommend further evaluation by a qualified licensed contractor.

Gaps were noted between the drywall and the exposed beams. The gaps can be sealed for cosmetic improvements. Cracks and peeling paint were noted at the ceiling above the master bathroom shower stall. Recommend further evaluation and improvements by a qualified licensed contractor.

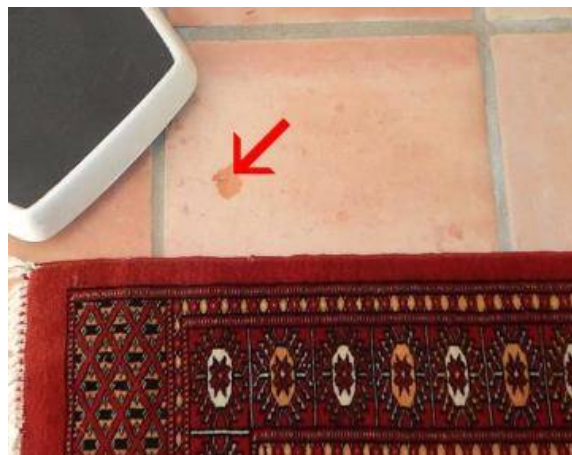
Chipped floor tiles were noted.

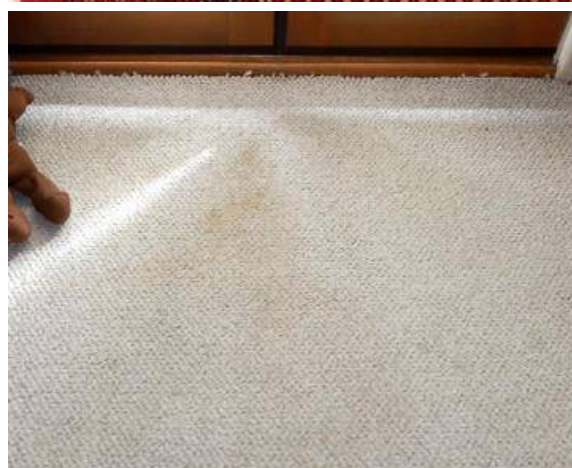
Stained carpet was noted in various places.

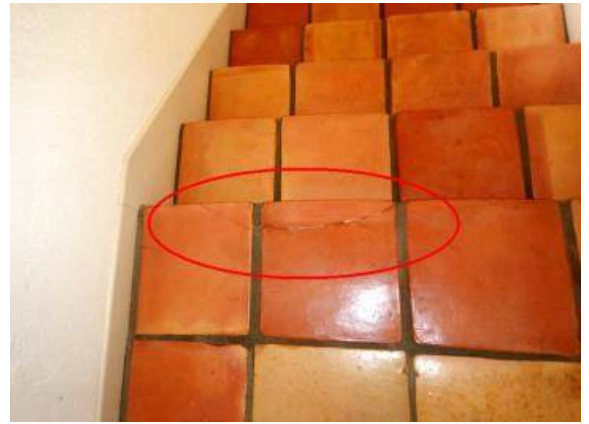
Broken tiles were noted at the top of the stairs. Recommend further evaluation and improvements by a qualified licensed contractor.

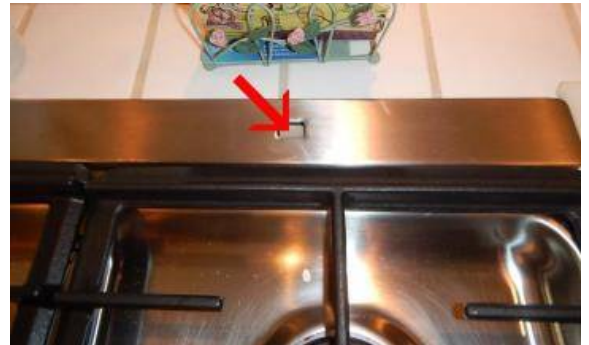
A missing power button cover was noted at the downdraft vent system controls.

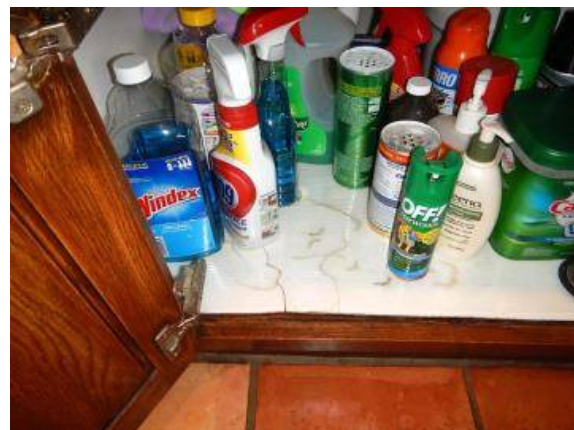
Damage was noted at the cabinet floor below the kitchen sink.

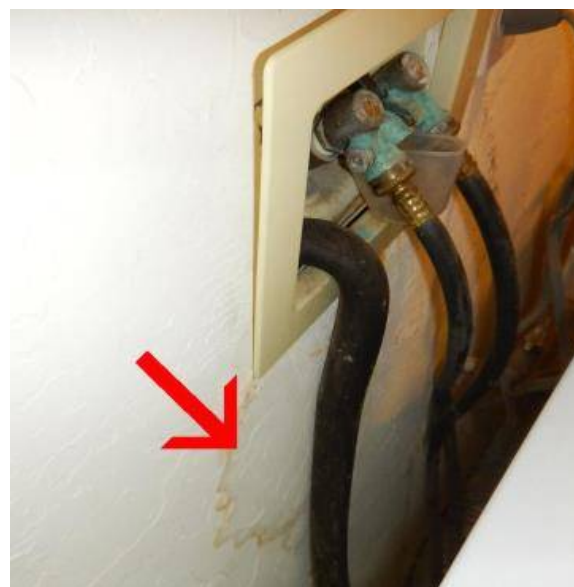
Moisture stains were noted on the wall below the laundry hookups.

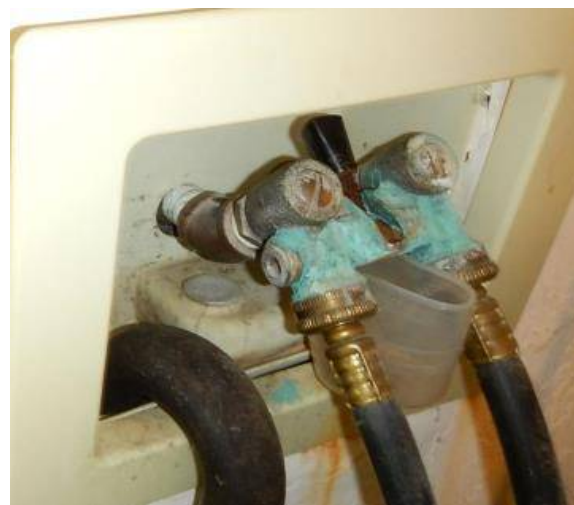
Excessive mineral deposits and evidence of leakage were noted at the laundry supply valve. Recommend improvements be made by a licensed plumbing.

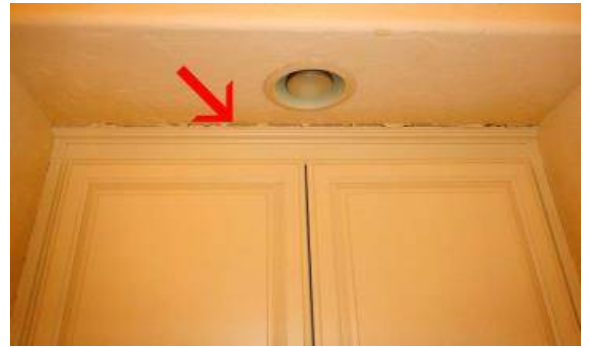
Gaps were noted between the crown molding and ceiling at the cabinets in the laundry room.

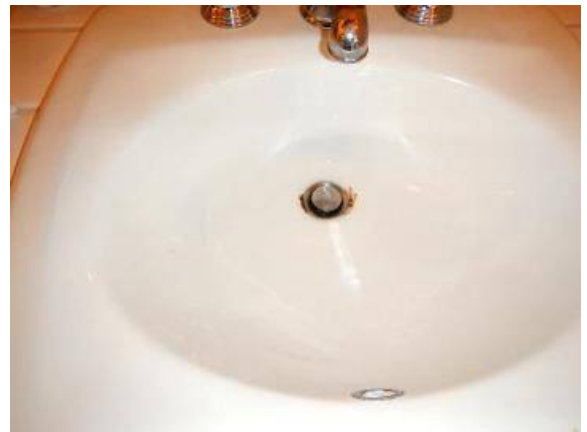
Chipped finish and rust was noted at the right sink in the master bathroom.

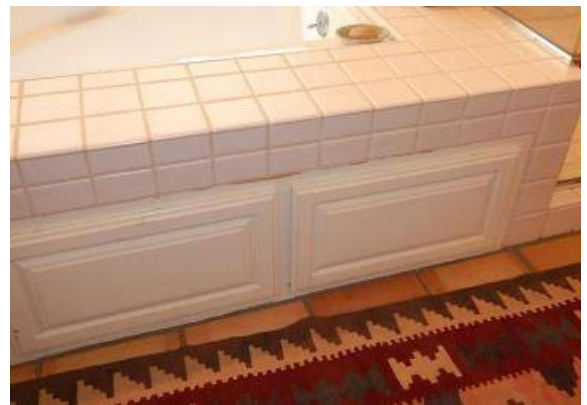
Peeling paint was noted at the side of the tub deck in the master bathroom.

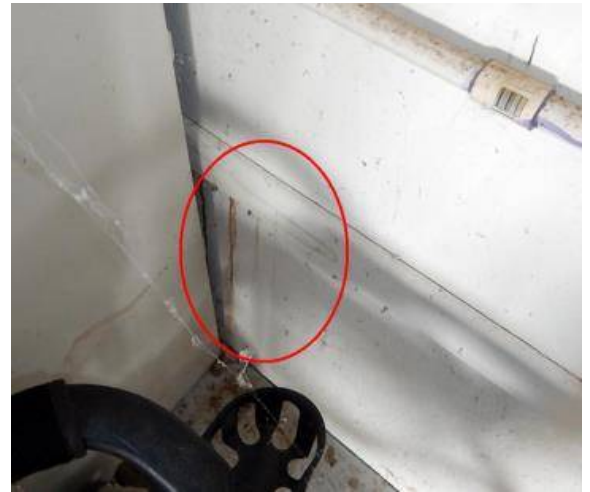
Moisture stains were noted in various places at the west interior of the garage.

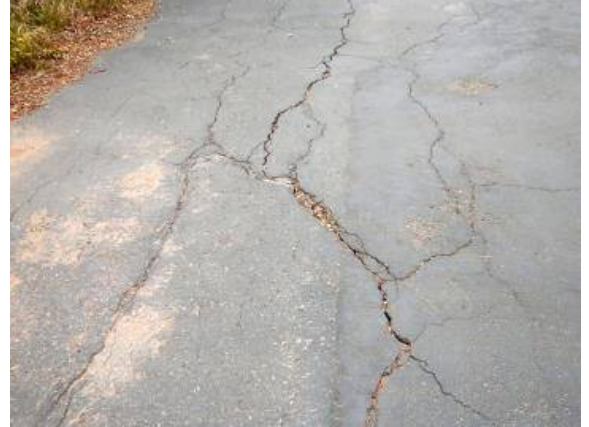
Open cracks were noted at the driveway. Recommend sealing open cracks to help prevent further damage of the pavement. Recommend resurfacing the asphalt as needed. Recommend further evaluation and improvements by a licensed paving contractor.

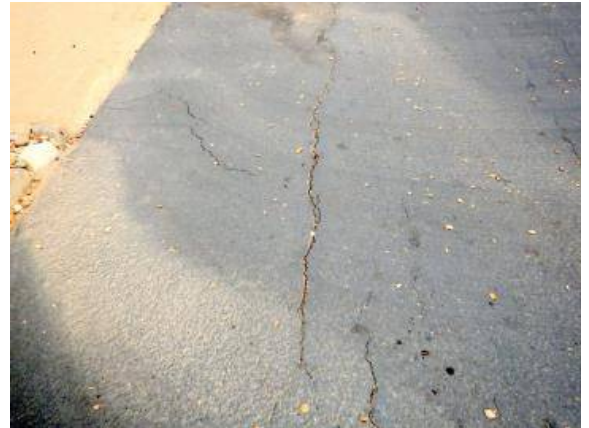
Open cracks were noted at the common driveway.

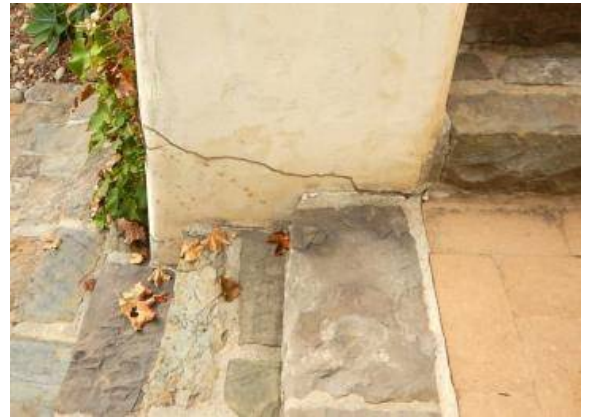
A crack and some displacement was noted at a front yard retaining wall adjacent to the stairs.

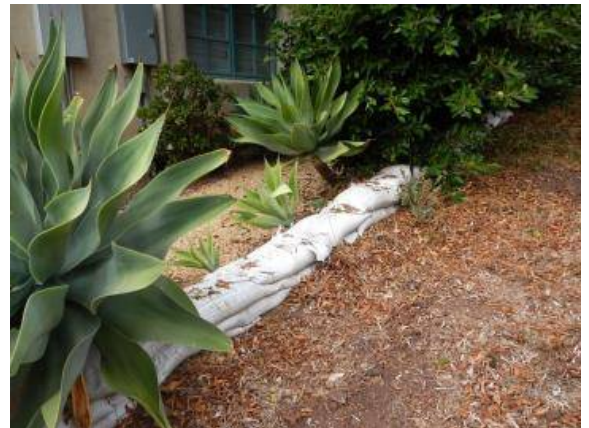
Sand bags were noted at the north side yard.

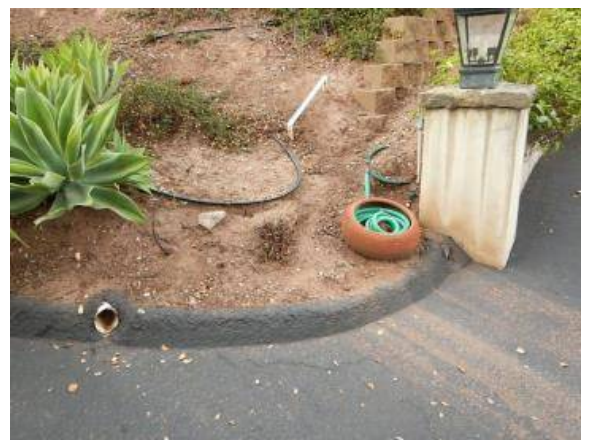
Bare dirt was noted at various places at the slopes. Erosion has occurred in various places. Recommend planting drought tolerant foliage to help prevent erosion.

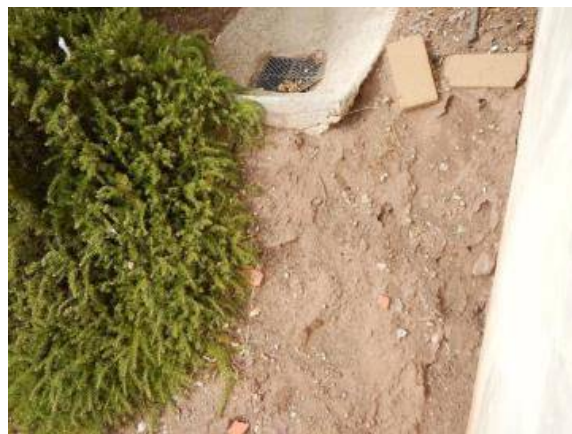
Bare dirt was noted at various places at the slopes. Erosion has occurred in various places.

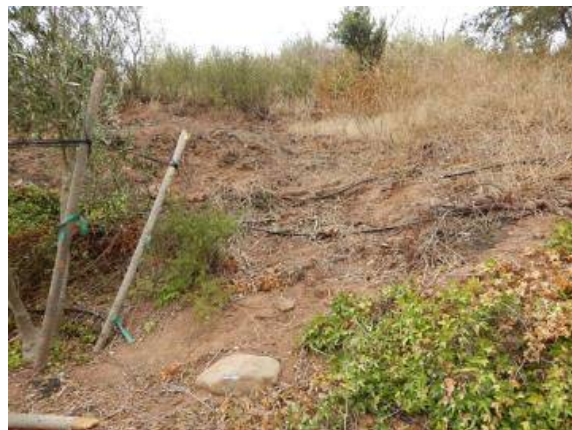
Bare dirt was noted at various places at the slopes. Erosion has occurred in various places.

Recommend the drainage adjacent to the buildings be improved by a qualified licensed contractor following the geotechnical engineer's recommendations.

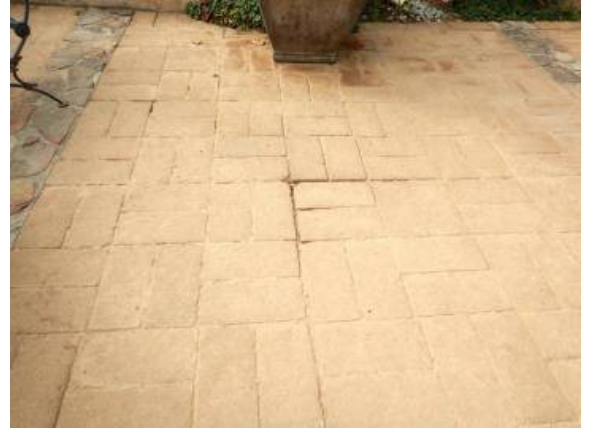
Worn pavers and missing mortar were noted in various places at the patios.

Recommend the patios be inspected and improved as needed by a qualified licensed contractor.

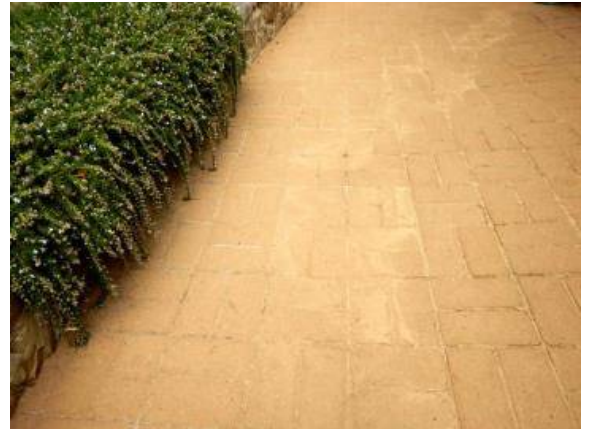
Evidence of ponding was noted at the rear patio.

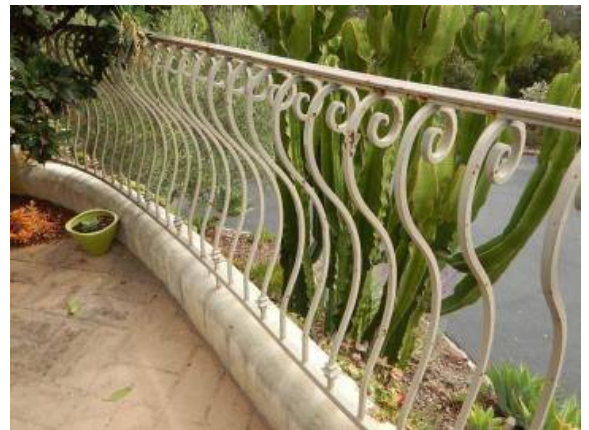
Rust was noted at a front patio railing.

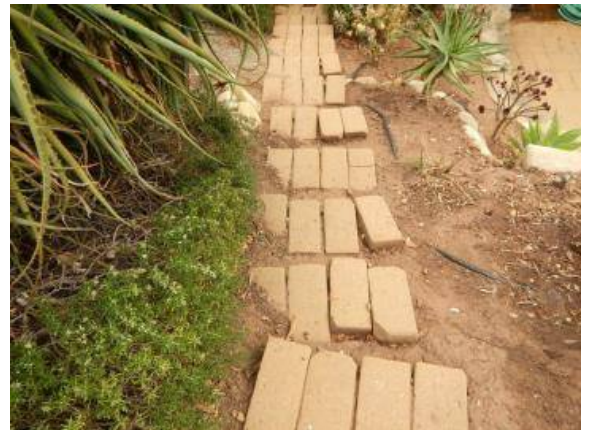
Temporary steps were noted at the northwest yard. Loose and displaced pavers were noted at these steps.

Recommend the exterior stairs and related components be inspected and improved as needed by a qualified licensed contractor.

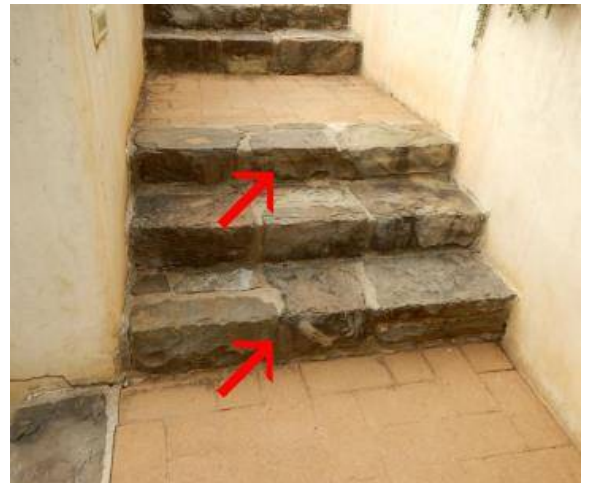
Uneven risers were noted at the front yard stairs. Some of the risers are too high.

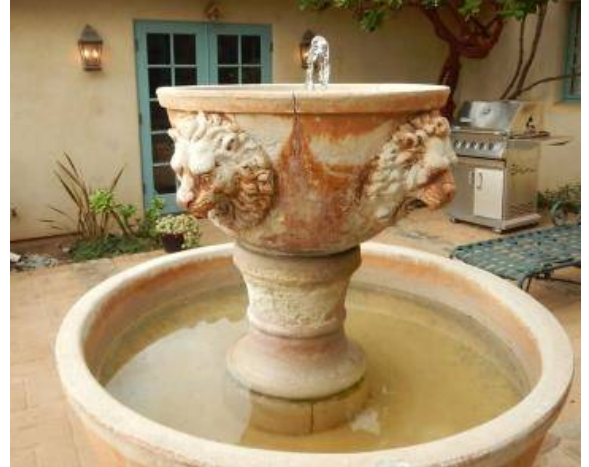
Cracks were noted in the front patio fountain.

Recommended the fountains and related equipment be inspected and improved or replaced as needed by a qualified specialist.

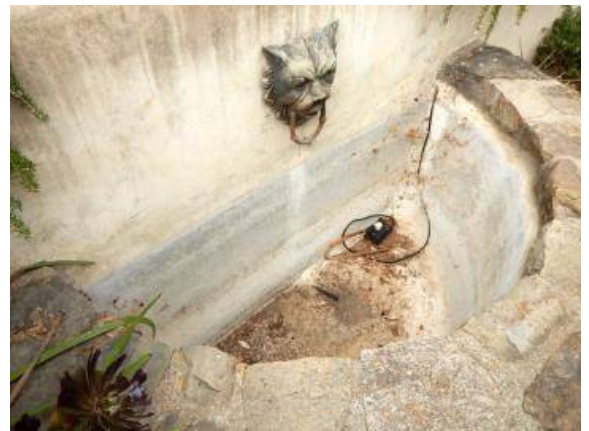
The rear patio fountain was empty at the time of inspection.
