## INSPECTION REPORT

1439 Tunnel Road  
Santa Barbara, CA

Prepared for Mr. and Mrs. Harrison  
October 31, 2017

**Reinspection - March 1, 2018**

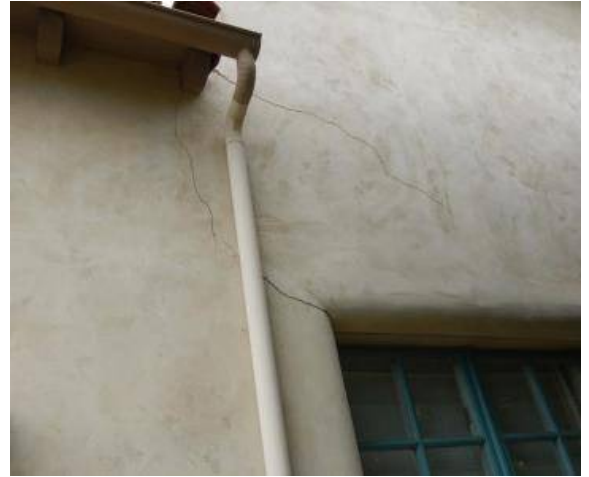
Unusual cracks were noted at the north side of the building above the main electrical panel. Recommend further evaluation by a qualified licensed contractor and geotechnical engineer.

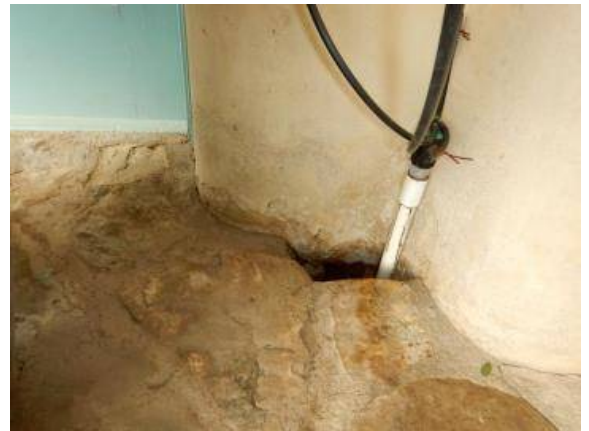
Open cracks were noted in various places at the exterior walls. Recommend sealing open cracks to help prevent water intrusion.

Damaged stucco was noted adjacent to the patio between the entry and living room.

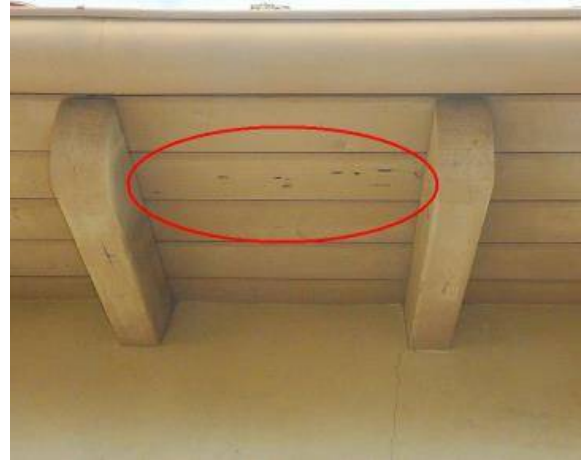
Apparent insect damage was noted in various places at the eaves and master bedroom balcony. Recommend the entire property be inspected by a licensed structural pest control operator.

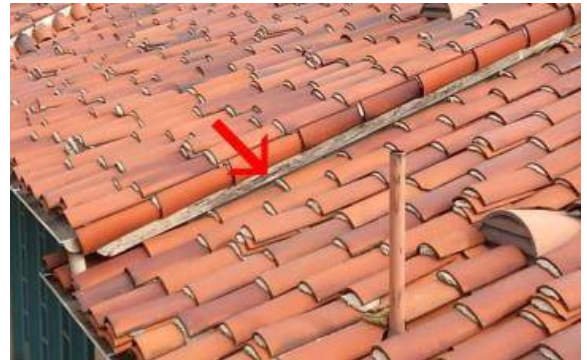
An excessively weathered fascia board was noted between the upper and lower roofs at the upper south portion of the house.

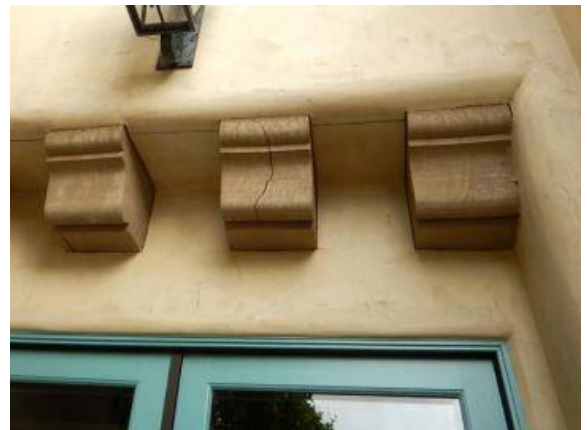
Weathered wood components were noted in various places at the exterior of the building.

Recommend all exterior wood components be painted or sealed as needed by a licensed painting contractor to help prevent moisture damage.

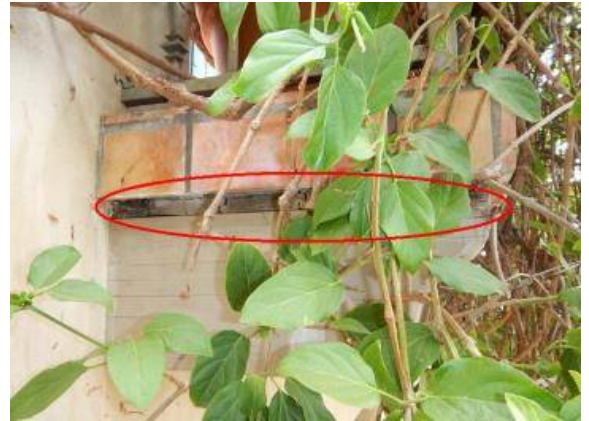
Lack of proper flashings were noted at the master bedroom balcony.

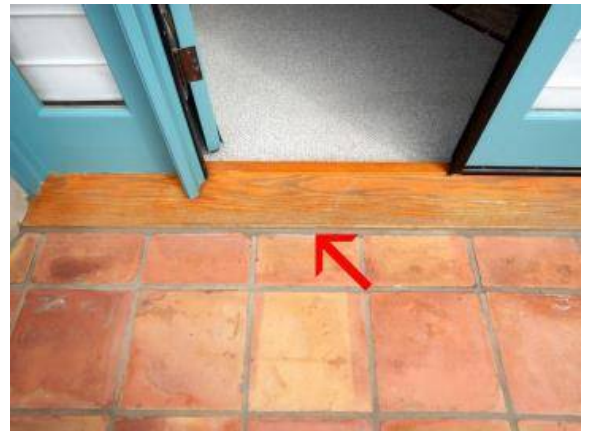
Gaps were noted between the threshold and tile at the master bedroom balcony.

Gaps have been sealed between the threshold and tile at the master bedroom balcony. Additional improvements will likely still be needed at the master bedroom balcony.

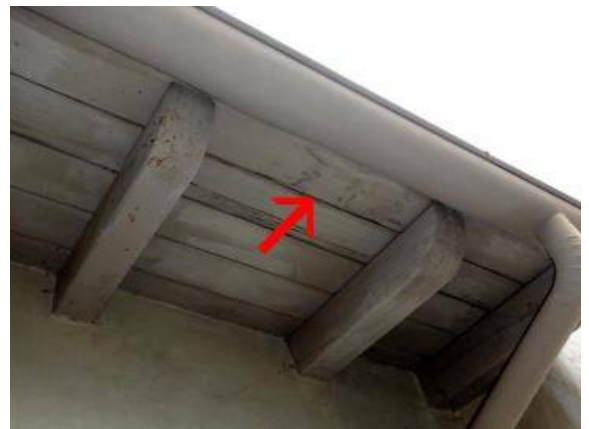
Moisture stains were noted at the eaves above the master bedroom balcony.

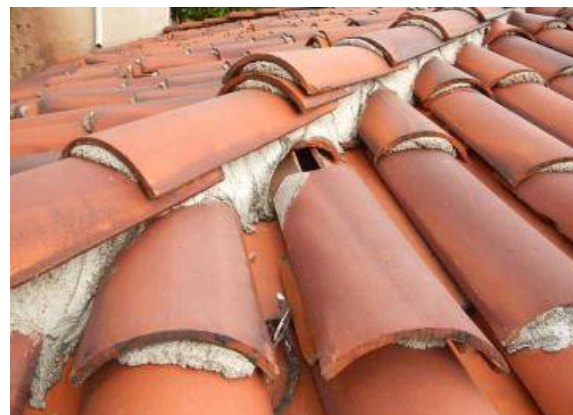
A broken roof tile was noted at the south side of the garage.  
**See below.**

Recommend the roofs and related components be inspected and improved as needed by a licensed roofing contractor.

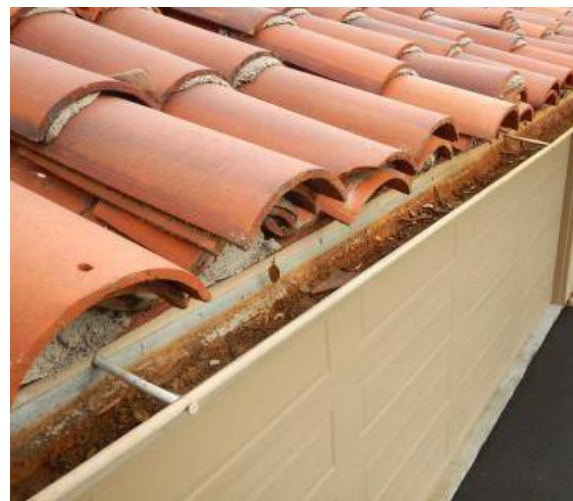
Corrosion was noted in various places at the gutters.

Recommend the gutters be cleaned, inspected, and improved as needed by a qualified licensed contractor. Recommend extending downspouts away from the building to help prevent water intrusion and foundation movement. Underground drains are not within the scope of this inspection.

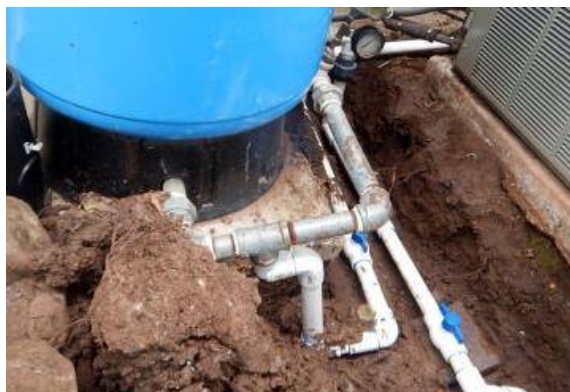
Corrosion was noted at a galvanized pipe adjacent to the pressure tank at the north exterior. **Numerous pipes and fittings have been replaced adjacent to the pressure tank.**

Recommend the water pump, pressure tank, and related components at the north exterior be inspected and improved as needed by a licensed plumbing contractor.

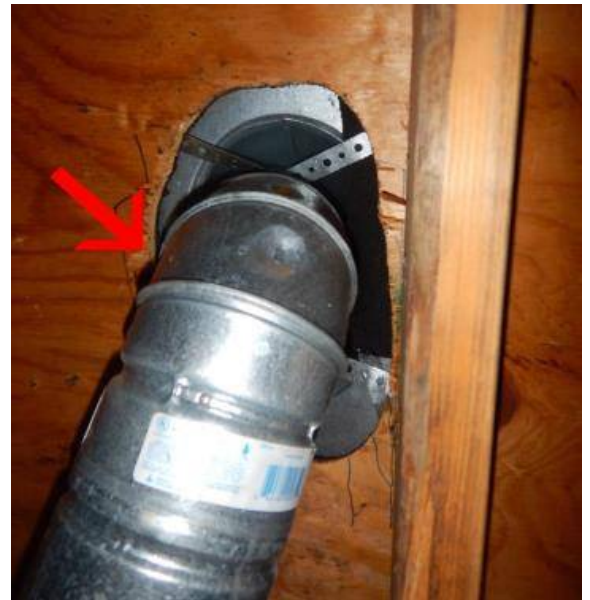
The furnace vent pipe is too close to wood at the roof sheathing in the attic. Recommend the wood be trimmed away 1" to provide adequate clearance.

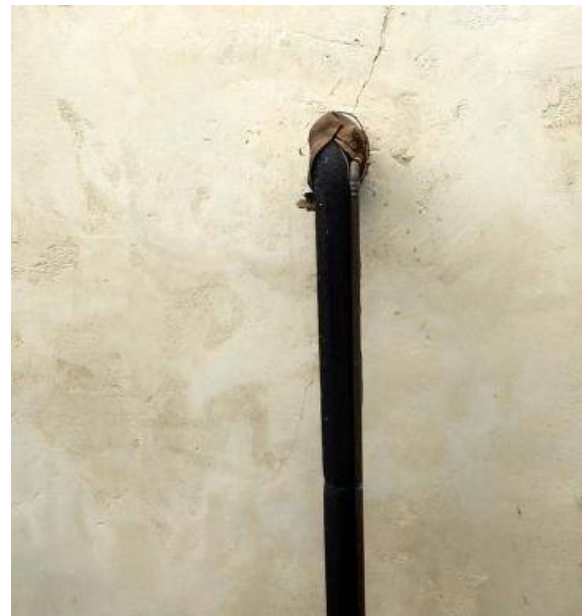
Recommend covering the refrigerant line insulation with UV resistant tape.

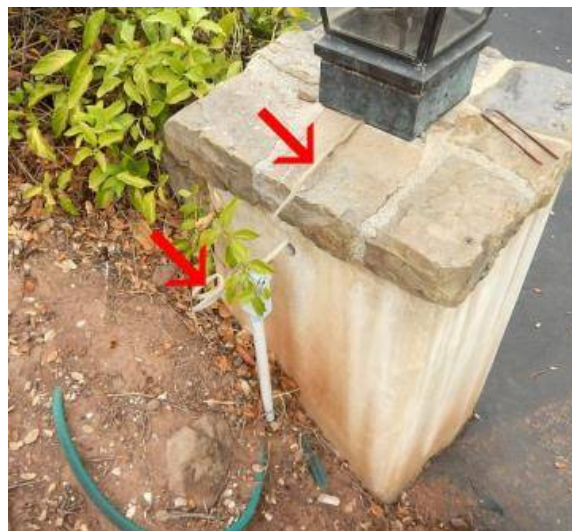
Temporary wiring was noted at a landscape light south of the garage. Landscape lighting and wiring is otherwise not within the scope of this inspection. Recommend further evaluation and improvements by a licensed electrician.

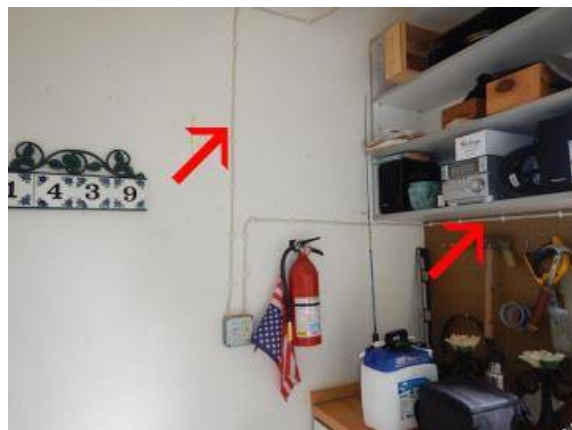
Temporary wiring was noted at various places in the garage. Recommend improvements be made by a licensed electrician.

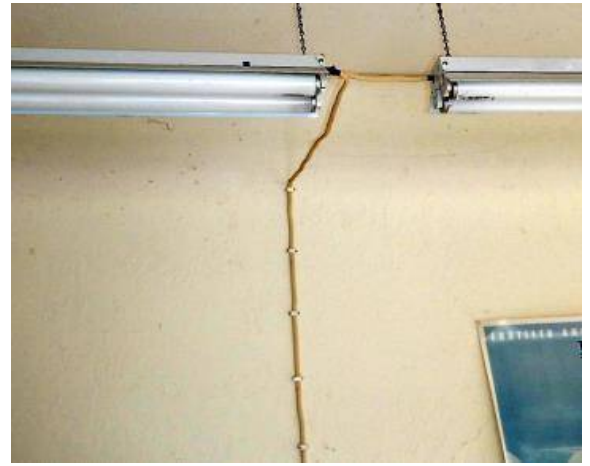
Temporary wiring was noted at various places in the garage.

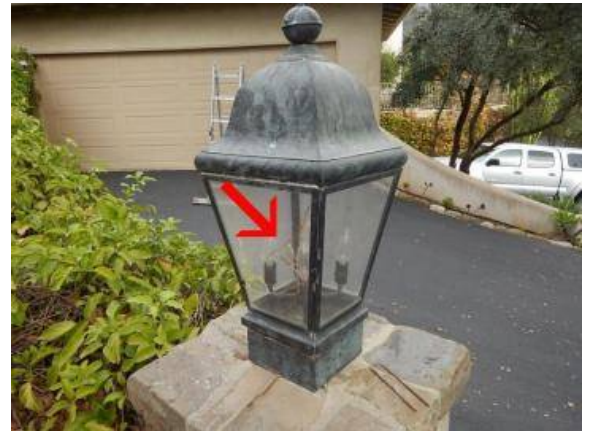
Ground Fault Circuit Interrupter (GFCI) protection is recommended at garage receptacles. The GFCI receptacle at the rear interior of the garage did not trip when tested. Recommend improvements be made by a licensed electrician. GFCI protection is recommended at all kitchen receptacles (the receptacles adjacent to the kitchen sink are GFCI protected). GFCI protection was not required at all kitchen receptacles at time of construction but is recommended. Broken glass was noted at a landscape light south of the garage.

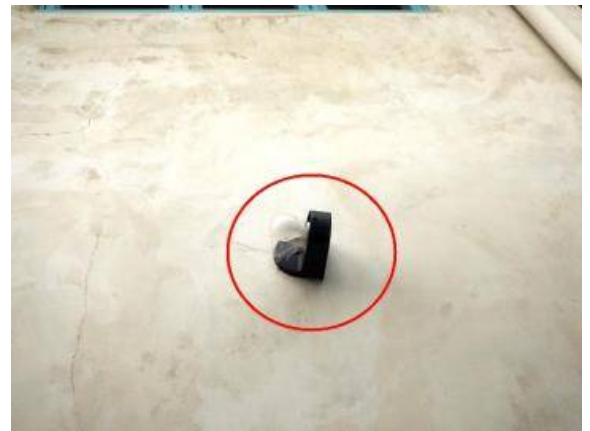
A displaced light fixture with a missing globe was noted at the north exterior.

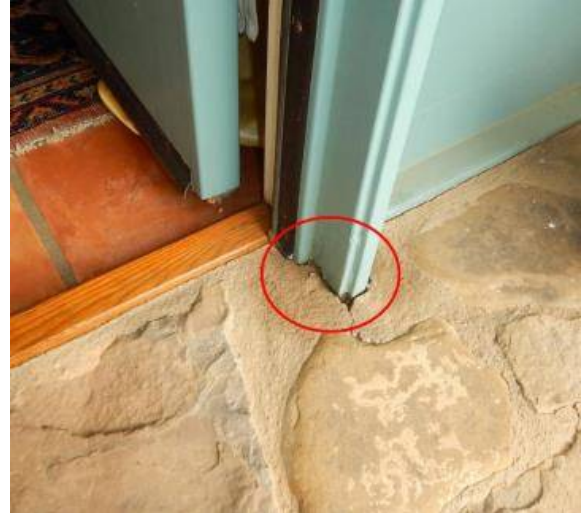
Some of the exterior door frames are embedded in paving. This can cause moisture damage. Recommend monitoring and improving as needed. Recommend keeping these areas well sealed to help prevent moisture damage.

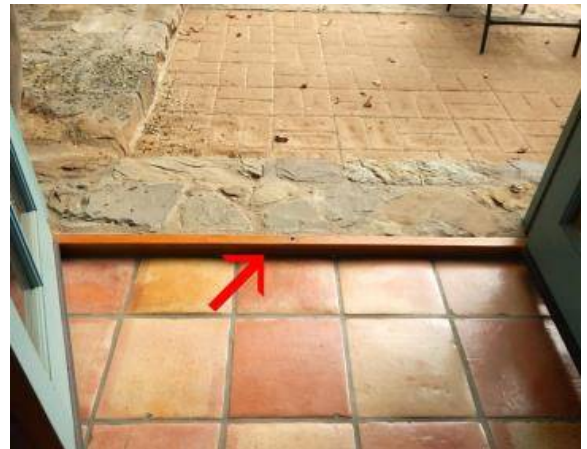
High thresholds were noted at the living room and family room. High thresholds can be trip hazards and are not to current standards.

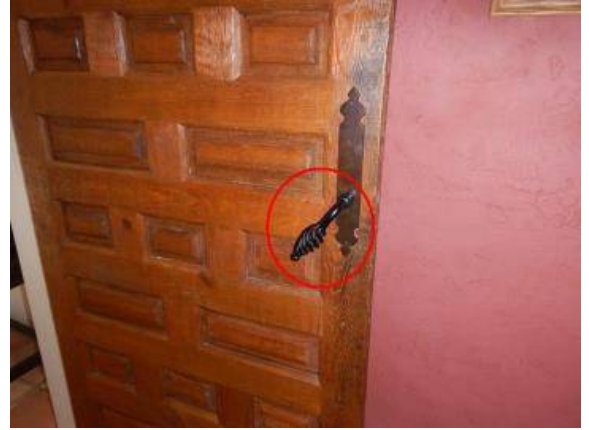
Weak springs were noted at the door hardware at the lower level bedroom. The door levers do not stay horizontal.

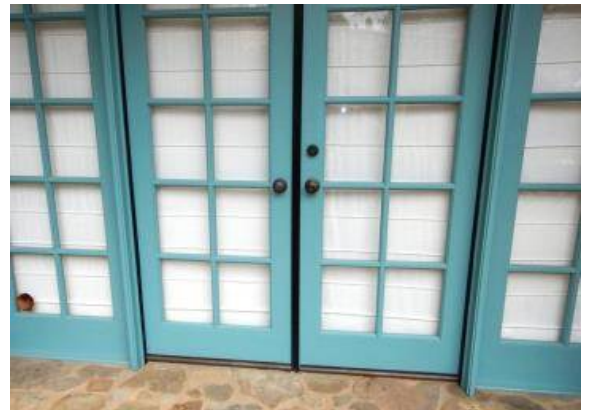
Weathered windows were noted in various places. Peeling paint was noted at some of the windows. **Some of the doors and windows have been repainted.**

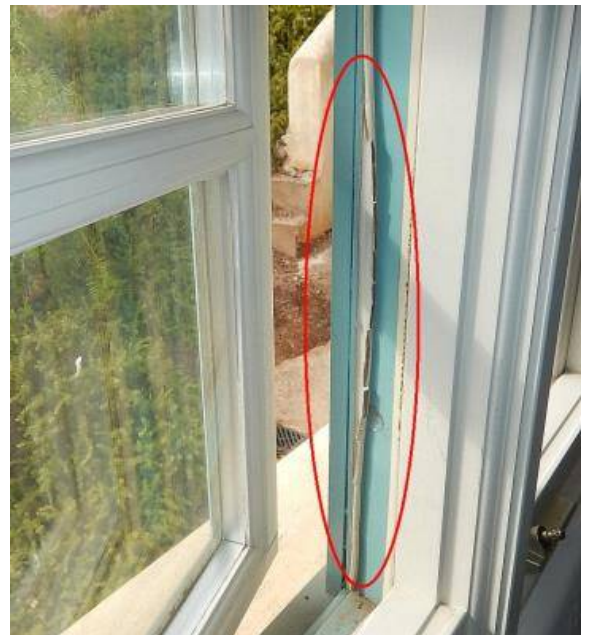
Damaged weatherstripping was noted in various places at the windows.

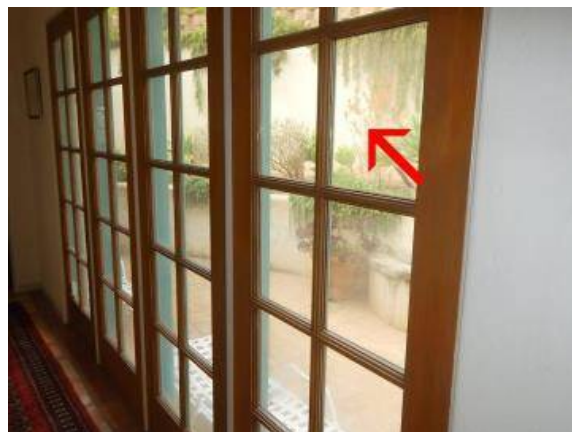
Fogging was noted between panes of glass at the upper hallway door and windows.

Additional failed dual pane windows and doors may be present, but not visible in all weather conditions or may be obscured by dirty glass. Recommend all of the windows and doors be cleaned to allow for further evaluation.

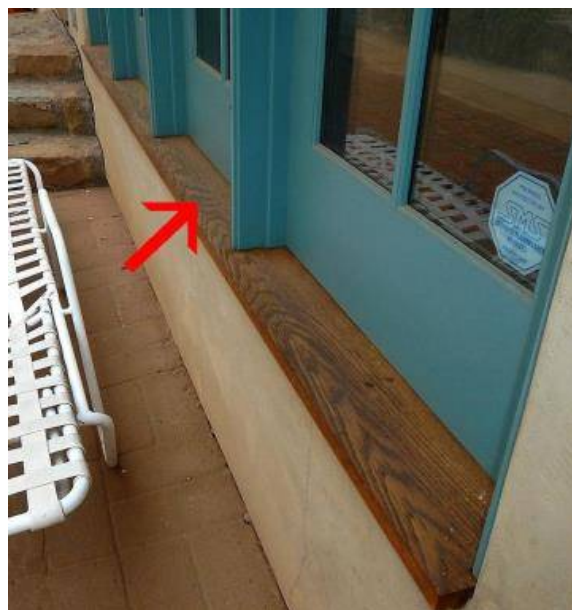
Weathered windowsills and thresholds were noted.

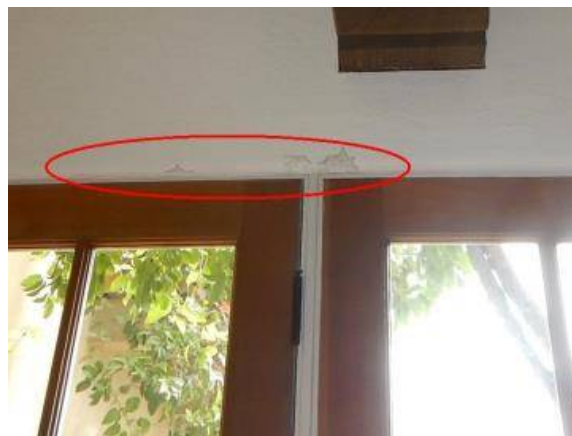
Moisture stains were noted at the wall above the living room exterior doors. Recommend further evaluation by a qualified licensed contractor.

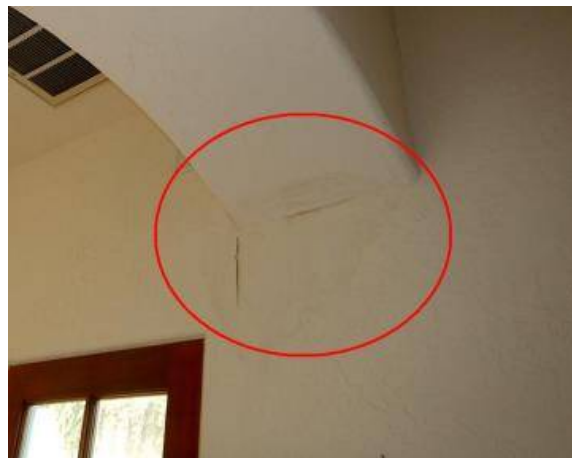
Moisture stains and damage were noted at the upper hallway ceiling and wall toward the rear of the building.

Moisture stains and damage have been repaired.

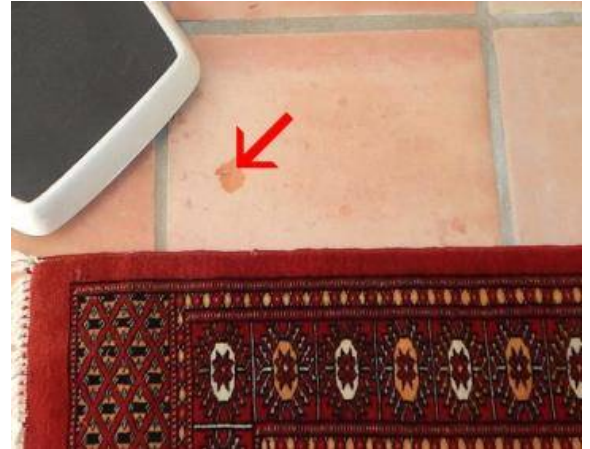
Chipped floor tiles were noted.

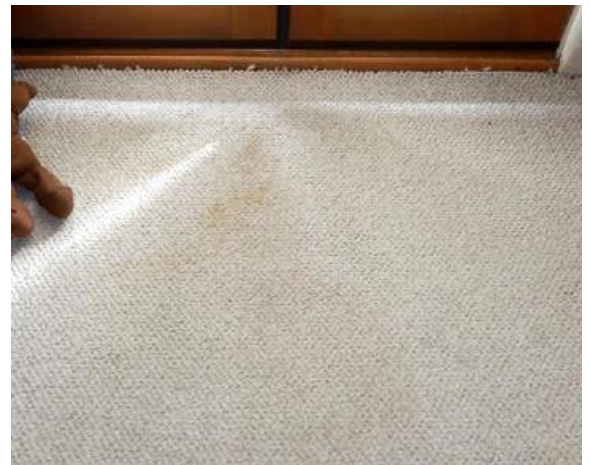
Stained carpet was noted in various places.

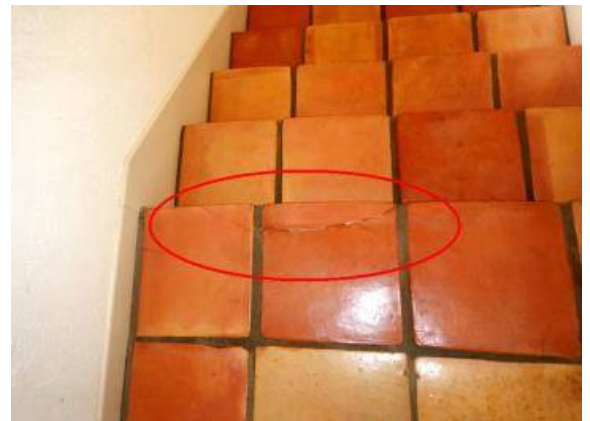
Broken tiles were noted at the top of the stairs. Recommend further evaluation and improvements by a qualified licensed contractor.

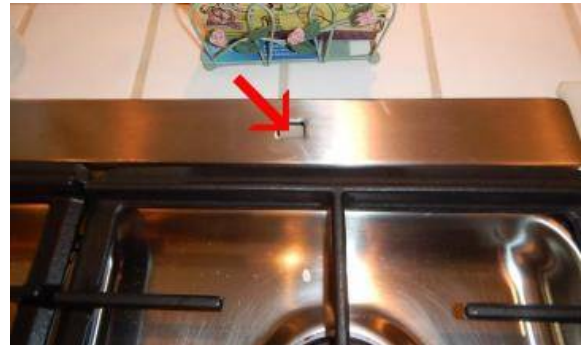
A missing power button cover was noted at the downdraft vent system controls.

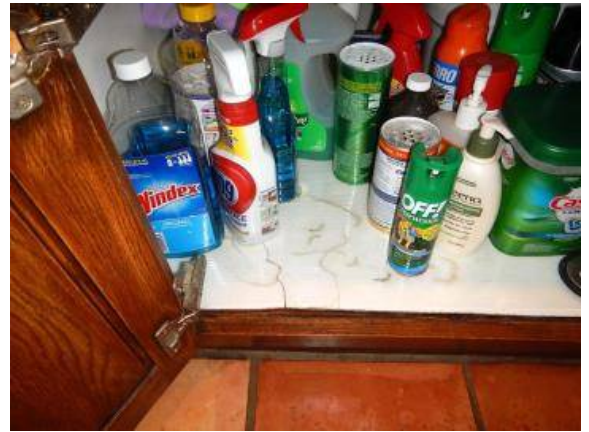
Damage was noted at the cabinet floor below the kitchen sink.

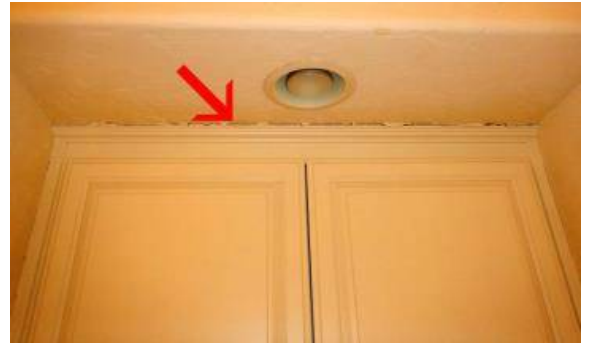
Gaps were noted between the crown molding and ceiling at the cabinets in the laundry room.

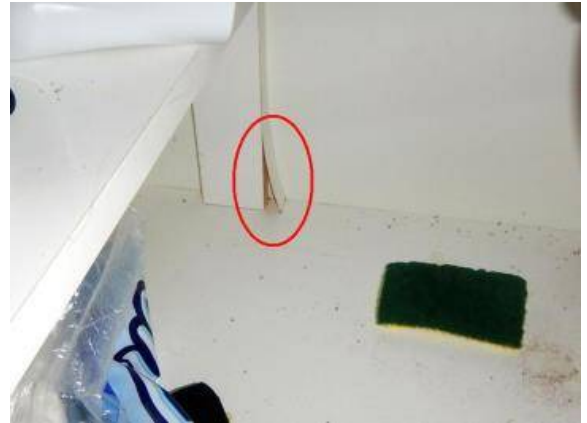
A small piece of delaminated material was noted in the cabinet below the sink at the lower level bedroom bathroom.

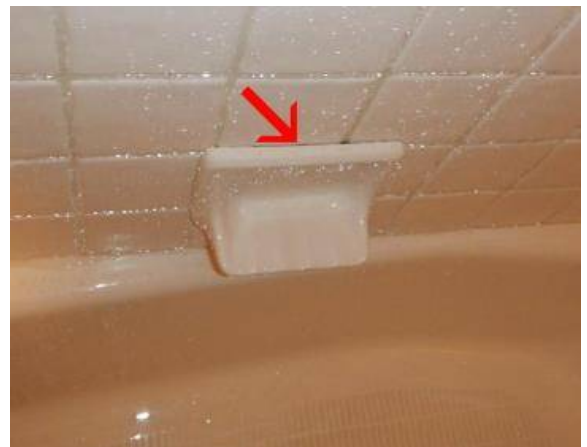
Grout or sealant is recommended between the soap dish and wall at the lower level bedroom bathroom. **Repairs have been made.**

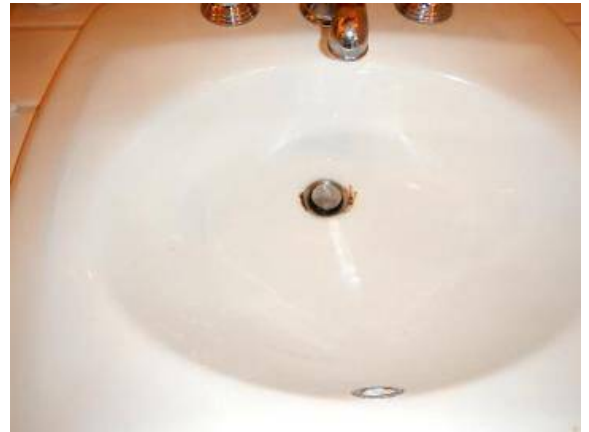
Chipped finish and rust was noted at the right sink in the master bathroom.

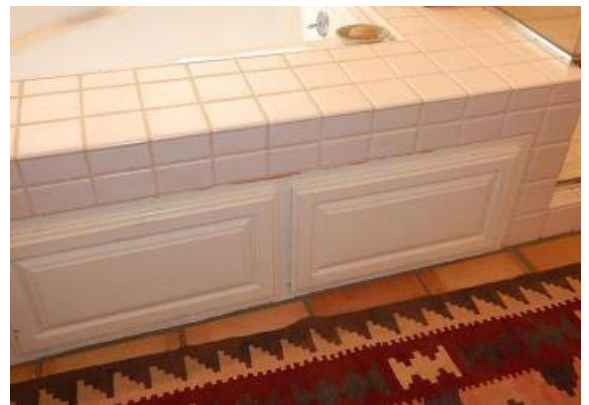
Peeling paint was noted at the side of the tub deck in the master bathroom. **This area has been repainted.**

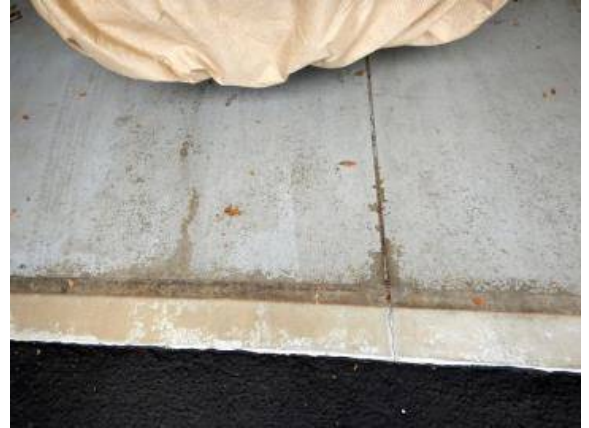
Worn paint was noted at the garage floor.

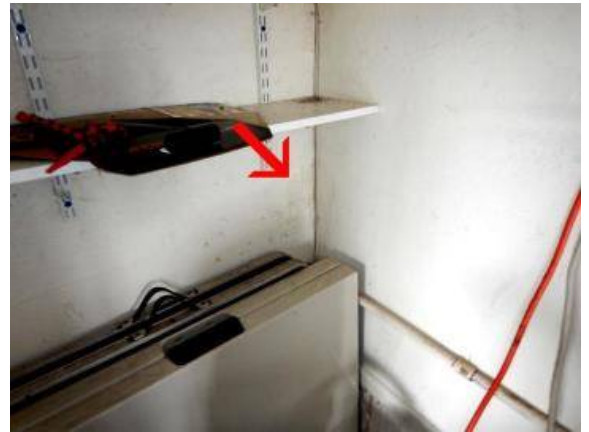
Moisture stains were noted in various places at the west interior of the garage. This area is below grade. Recommend further evaluation by a qualified licensed contractor.

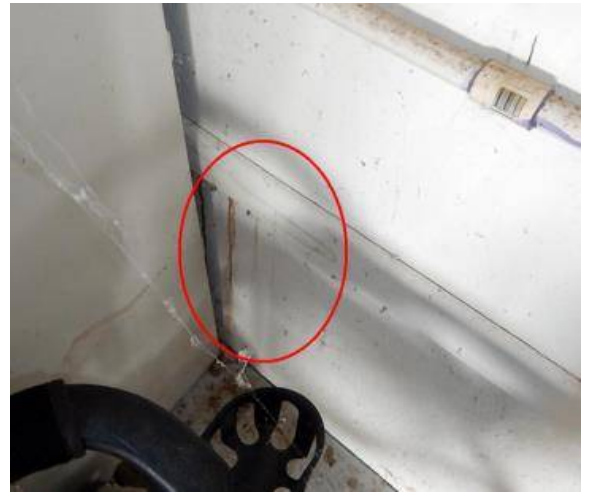
Moisture stains were noted in various places at the west interior of the garage.

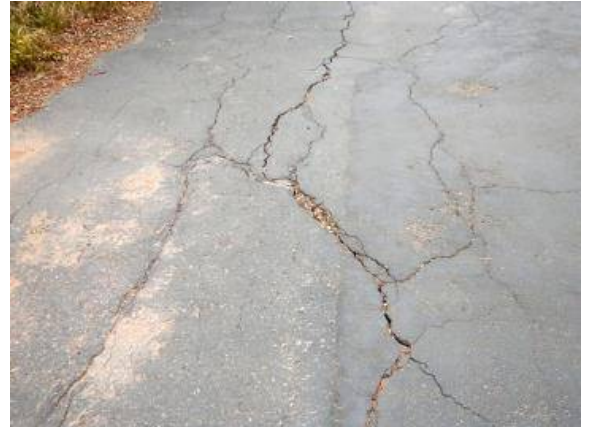
Open cracks were noted at the driveway. Recommend sealing open cracks to help prevent further damage of the pavement. Recommend resurfacing the asphalt as needed. Recommend further evaluation and improvements by a licensed paving contractor.

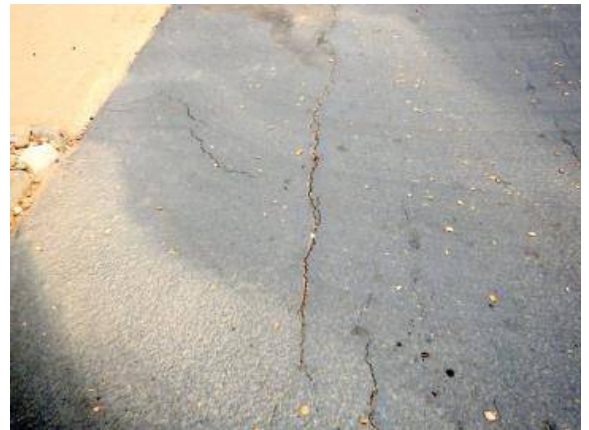
Open cracks were noted at the common driveway.

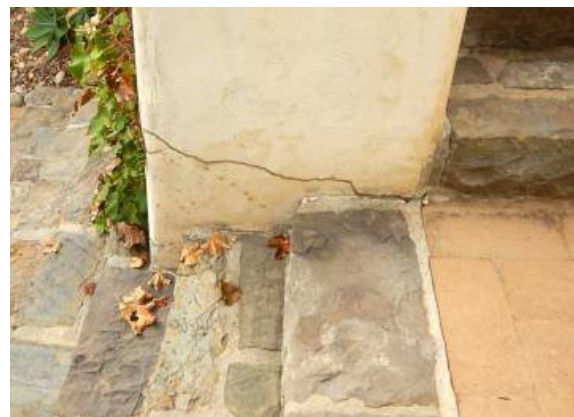
A crack and some displacement was noted at a front yard retaining wall adjacent to the stairs.

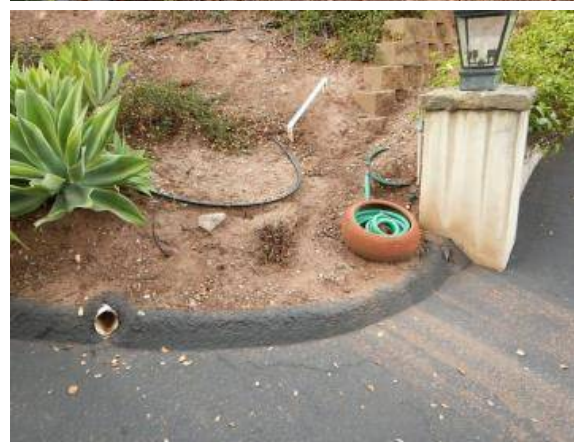
Bare dirt was noted at various places at the slopes. Erosion has occurred in various places. Recommend planting drought tolerant foliage to help prevent erosion.

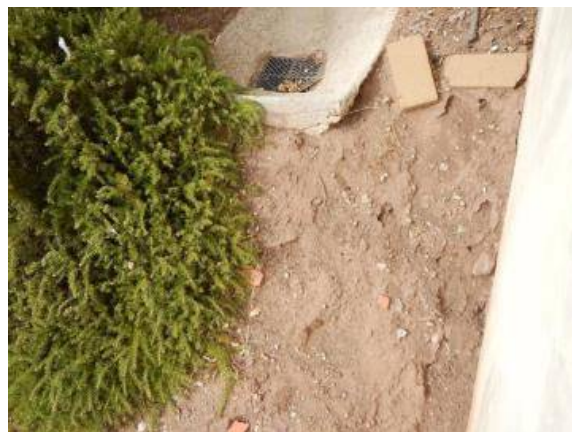
Bare dirt was noted at various places at the slopes. Erosion has occurred in various places.

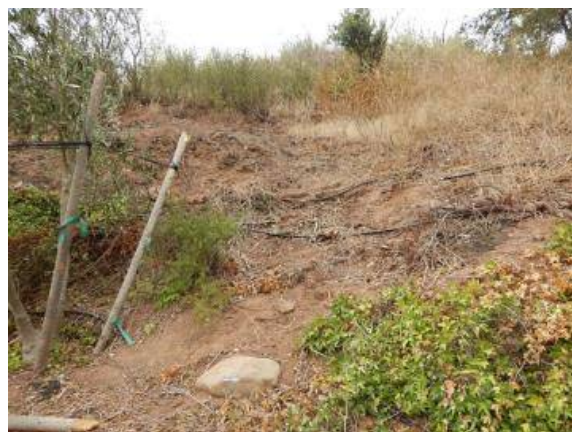
Bare dirt was noted at various places at the slopes. Erosion has occurred in various places.

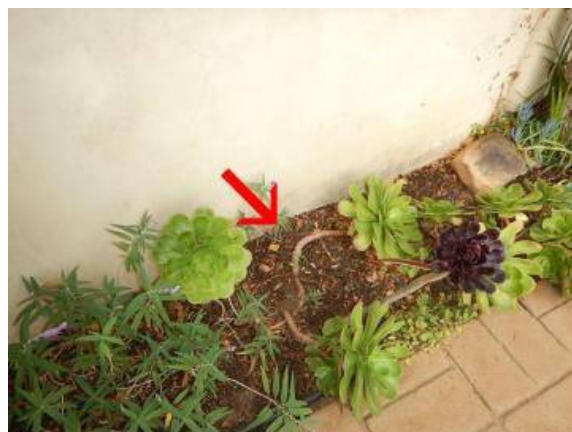
The soil is too high in some areas of the planters adjacent to the building. Recommend lowering the soil below the stucco screed.

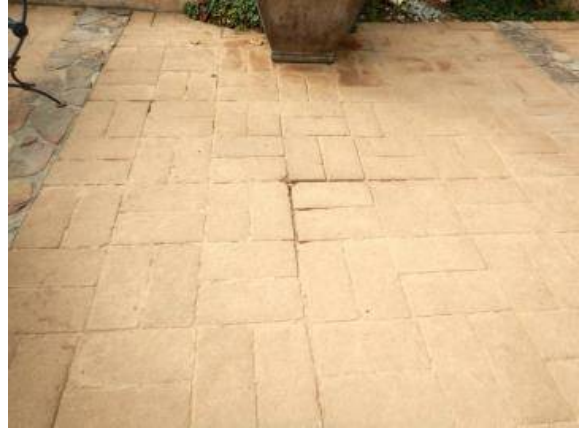
Worn pavers and missing mortar were noted in various places at the patios.

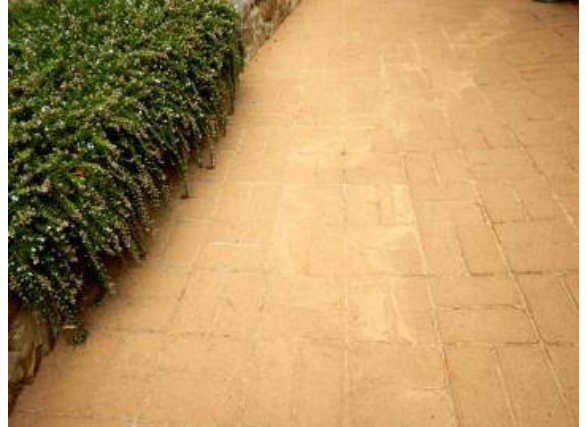
Evidence of ponding was noted at the rear patio.

Recommend the patios be inspected and improved as needed by a qualified licensed contractor.

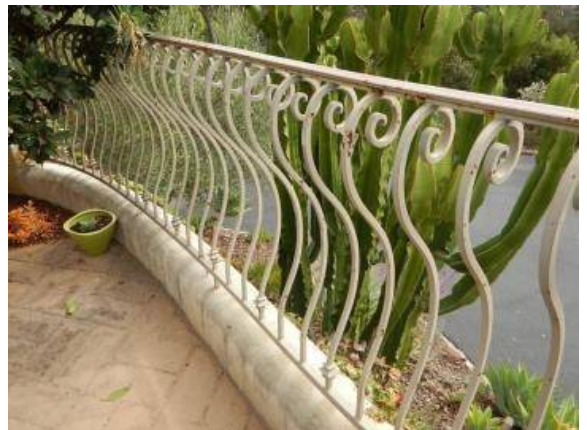
Rust was noted at a front patio railing.

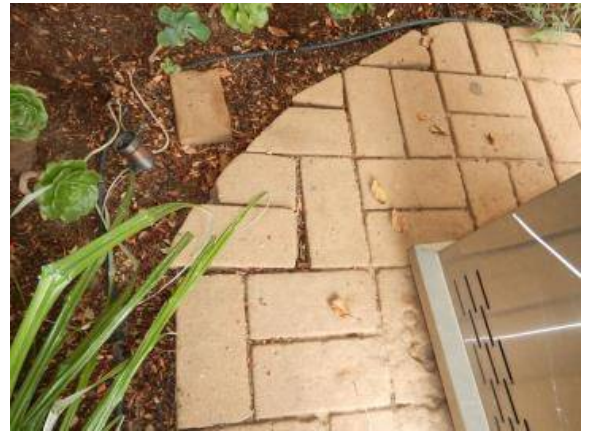
Displaced pavers were noted at a front patio.

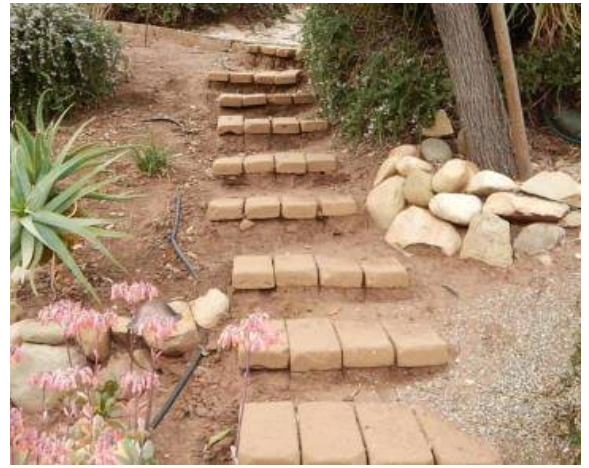
Temporary steps were noted at the northwest yard. Loose and displaced pavers were noted at these steps. **The steps in the northwest yard have been improved but are still loose.**

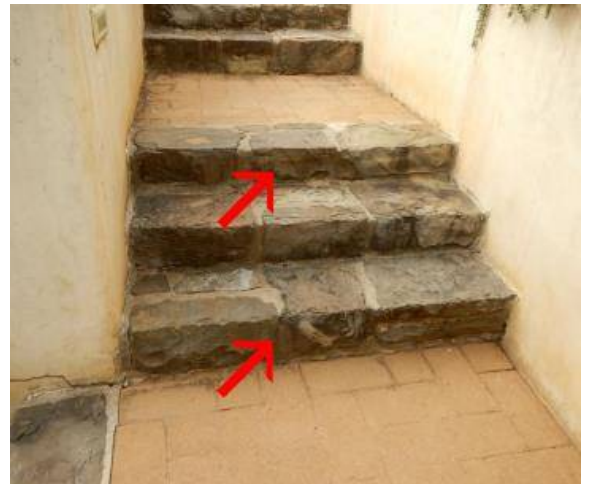
Uneven risers were noted at the front yard stairs. Some of the risers are too high.

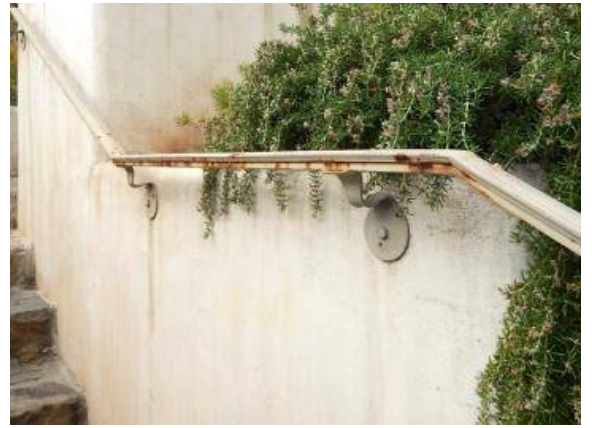
Rust was noted at the front yard handrails.

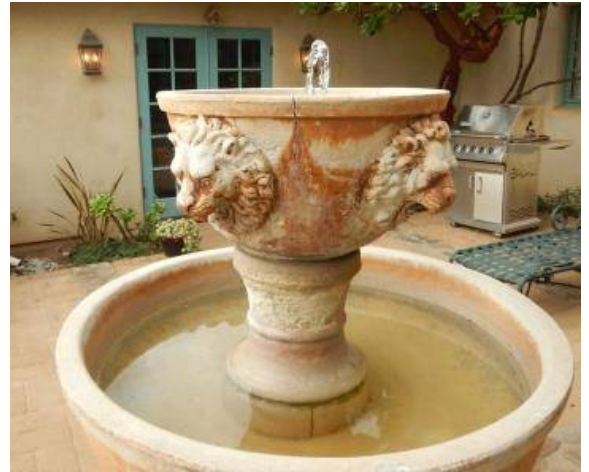
Cracks were noted in the front patio fountain.
