## INSPECTION REPORT

1439 Tunnel Road  
Santa Barbara, CA

Prepared for Mr. and Mrs. Harrison  
October 31, 2017

**Reinspection - March 1, 2018**

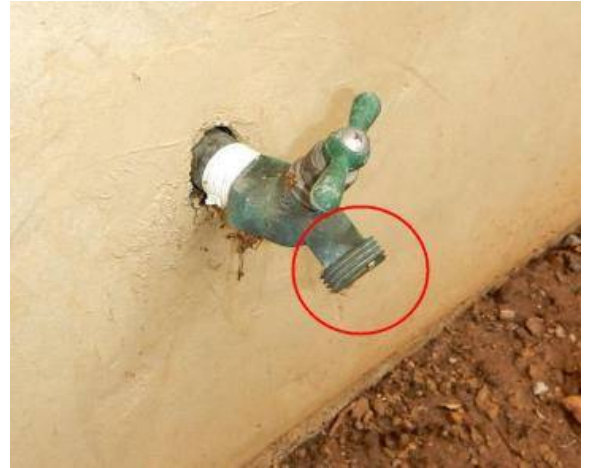
Recommend installing anti-siphon devices on all hose faucets. Lack of anti-siphon devices can allow water from the landscape to enter the potable water system, if hoses are left attached to faucets and the ends of the hoses are submerged.

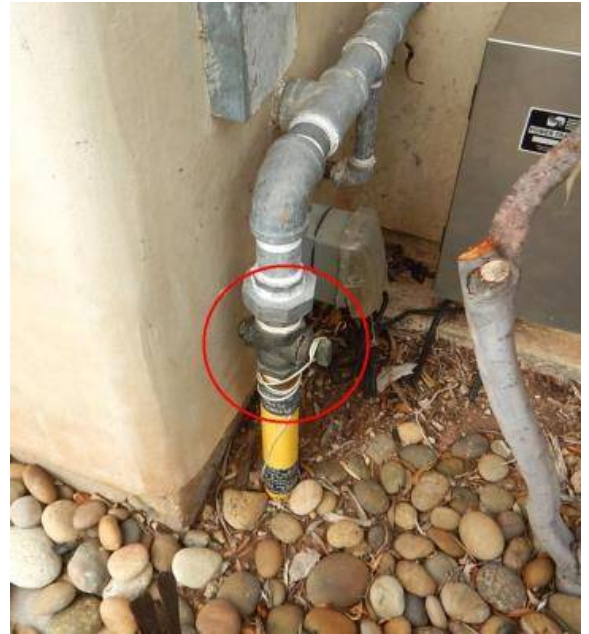
The gas meter and main gas shutoff were not located. Consult the utility company or owner for the location of the gas meter and main gas shutoff.

There is a gas shutoff valve at the front of the building.

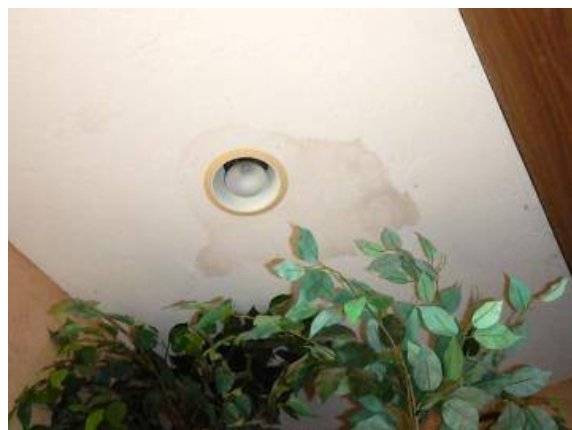
A moisture stain was noted at the family room ceiling below the balcony.

Stains in ceilings have been painted.

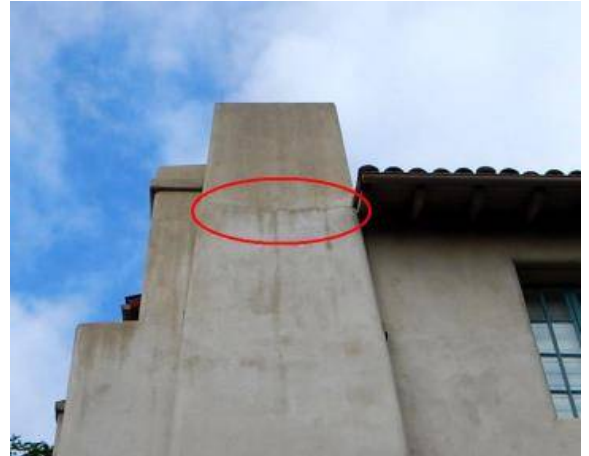
A crack was noted in the stucco at the chimney adjacent to the roof.

Recommend sealing any open cracks to help prevent water intrusion and damage.

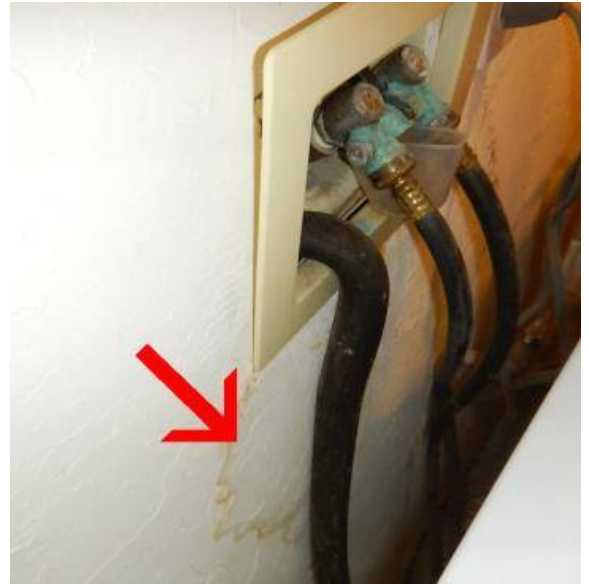
Moisture stains were noted on the wall below the laundry hookups.

**This area has been repainted.**

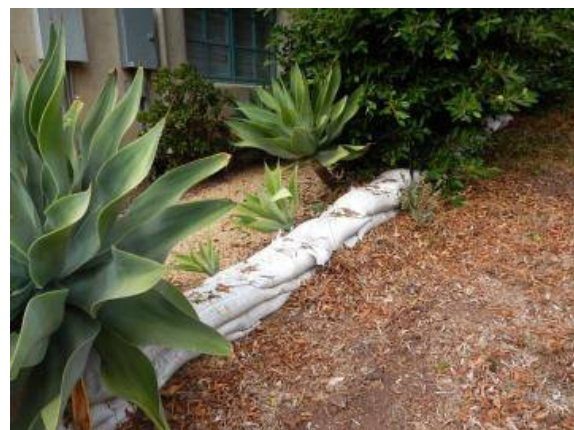
Steep slopes were noted. Evaluation of slope stability is not within the scope of this inspection. Recommend further evaluation of the entire property by a geotechnical engineer.

Sand bags were noted at the north side yard.

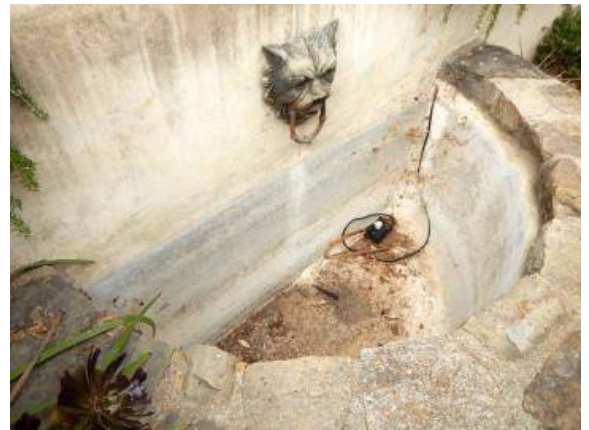
The rear patio fountain was empty at the time of inspection.

Recommended the fountains and related equipment be inspected and improved or replaced as needed by a qualified specialist.
