WOOD DESTROYING PESTS AND ORGANISMS INSPECTION REPORT

BUILDING NO. 165	STREET, CITY, STATE, ZIP La Vereda, Santa Barbara CA 93108	Date of Inspection 2/28/2017	No. of Pages 8
---------------------	---	---------------------------------	-------------------

General Description:
Two story stucco frame residence, tile roof, concrete slab, unimproved underarea, attached garage, detached workshop.

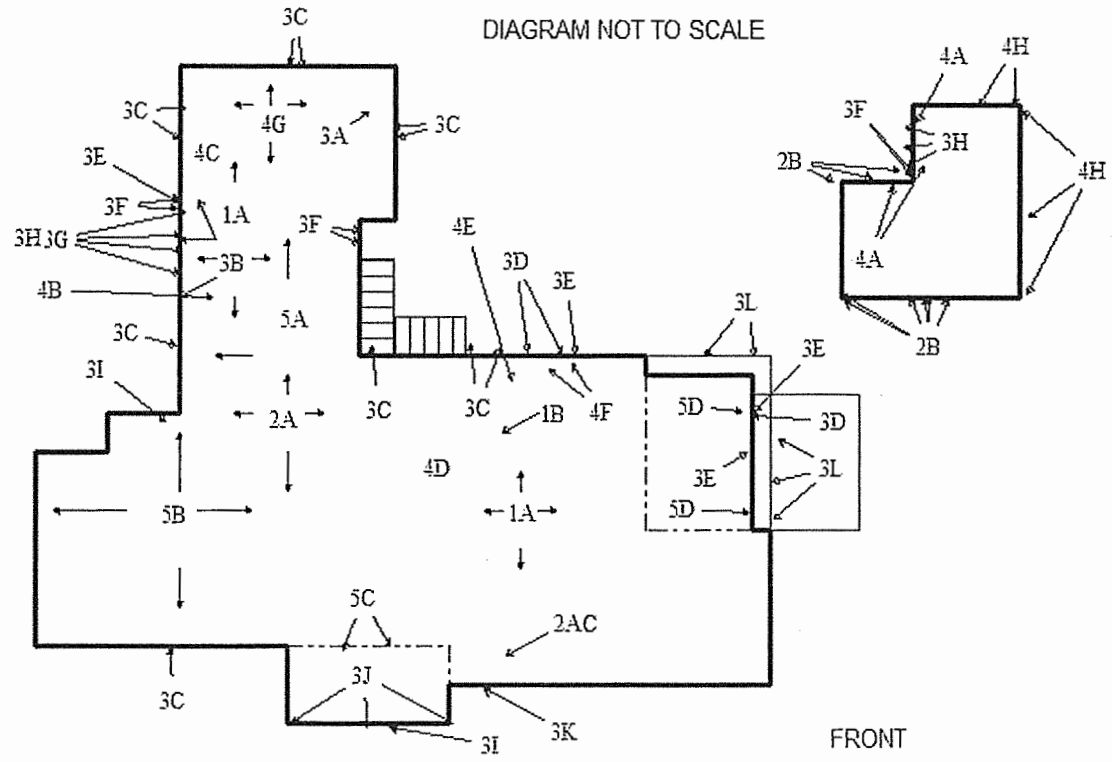
An inspection has been made to the structure(s) shown on the diagram in accordance with the Structural Pest Control Act. Detached porches, detached steps, detached decks and any other structures not on the diagram were not inspected.

ITEM 1A **Finding:** Cellulose debris and evidence of subterranean termites found at the subarea framing as indicated on the diagram by 1A.

ITEM 1B **Finding:** Subterranean termite damage found at the framing located in the subarea as indicated on the diagram by 1B.

ITEM 2A **Finding:** Evidence of drywood termites found at the at the attics, subarea, and detached garage exterior as indicated on the diagram by 2A. Infestations appear to extend into inaccessible areas.
