Building Inspections

## **INSPECTION REPORT**

1439 Tunnel Road  
Santa Barbara, CA

October 31, 2017

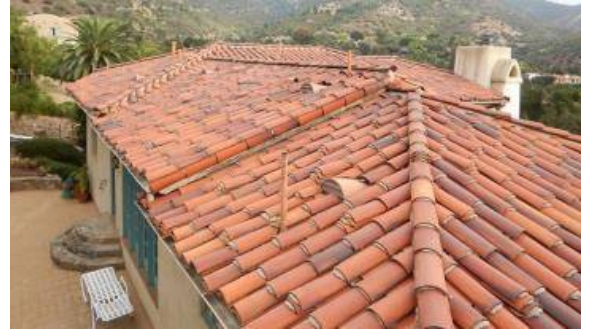
### ROOF ACCESS:

Roof access was limited due to type. The roofs were viewed from the ground and a ladder.

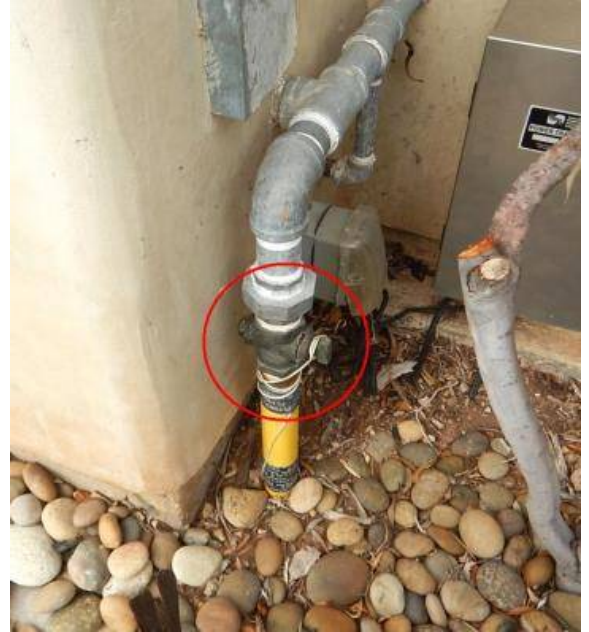
There is a gas shutoff valve at the front of the building.

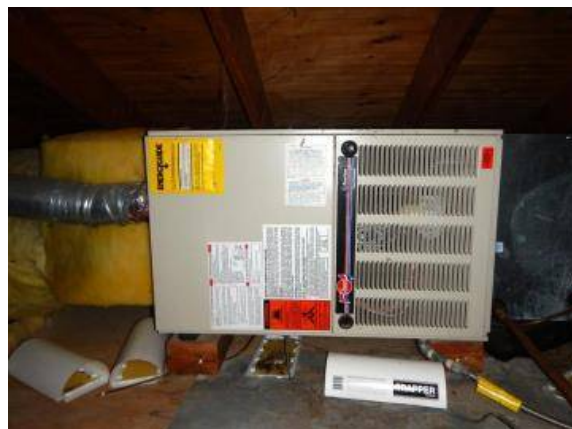
### LOCATION(S):

Attic.

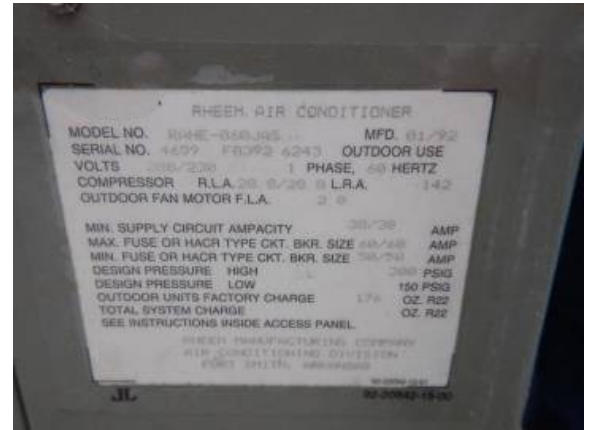
Approximately 25 years old (in service approximately 23 years).

Recommend covering the refrigerant line insulation with UV resistant tape.
